## ▶ AIRCRAFT

**SUBJECT:** INSPECTION OF D-2000 SERIES MAGNETO CAPACITORS AND CAPACITOR LEAD CRIMP TERMINALS

**REASON FOR BULLETIN:** To recommend the following:

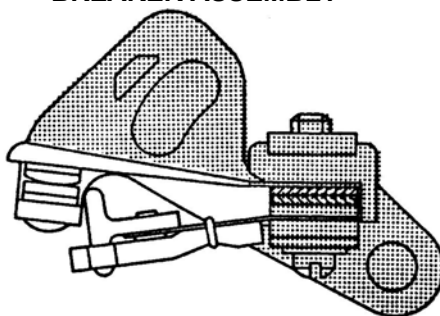
Figure 1

Field reports indicate that occasionally a breaker assembly will be found closed up due to melting of the cam follower directly under the breaker main spring as illustrated by figure 1, view "B" (view "A" shows normal condition of cam follower.)

VIEW A

NORMAL CAM FOLLOWER

VIEW B

MELTED CAM FOLLOWER

Cam follower melting may be caused (1) by deterioration of the crimp joint at the capacitor lead flag terminal or (2) by a capacitor internal failure. Either of these capacitor failures causes excessive breaker point arcing. Arcing results in heating of the breaker assembly main spring thus causing the follower to melt. Parts I & II of this bulletin detail the action to be taken to prevent this occurrence and instructions to correct this condition, if it exists.

- A. In the event it is determined the nylon cam follower material is melted in the location where the cam follower contacts the breaker main spring as shown in figure 1, the breaker assembly and the associated capacitor must be replaced with new parts.

**Do not reuse a capacitor associated with a melted cam follower breaker assembly.**

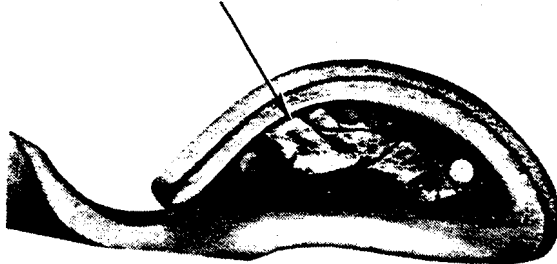
Figure 2

- A. Remove cover from magneto and capacitor from the cover.
- B. Visually inspect the flag terminal crimp joint for the following conditions. Inspection will be aided by using magnification, 4 power or greater.
  - 1. Examine crimp joint for evidence of a tinned wire bundle as illustrated in figure 2.

**TINNED WIRE IN CRIMP**

- 2. Look for evidence of a burning or an arcing appearance around the outline confinements of the wire bundle in the crimp area.
  - 3. Inspect the wire to flag terminal for evidence of conductor insulation extending within the confines of the wire crimp area. See figure 3.
- C. Corrective Action.
  - 1. If condition 1 is present, solder the conductor to the flag terminal following the soldering procedure outlined in paragraph D.

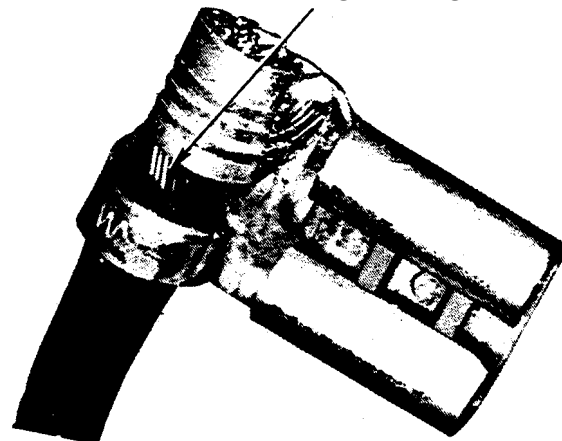
Figure 4

**WIRE STRANDS**

- 2. If condition 2 is discovered, replace with a new steel housing capacitor.
- 3. If condition 3 is evident, carefully attempt to move the insulation back from the crimp area to expose bare wire strands as shown in figure 4. Use a non metallic probe for this operation. If bare strands can be exposed as shown in figure 4, solder conductors to crimp area of flag terminal per soldering procedures outlined in paragraph D. If wire strands cannot be exposed and insulation appears to be caught within the conductor crimp area, replace the capacitor.

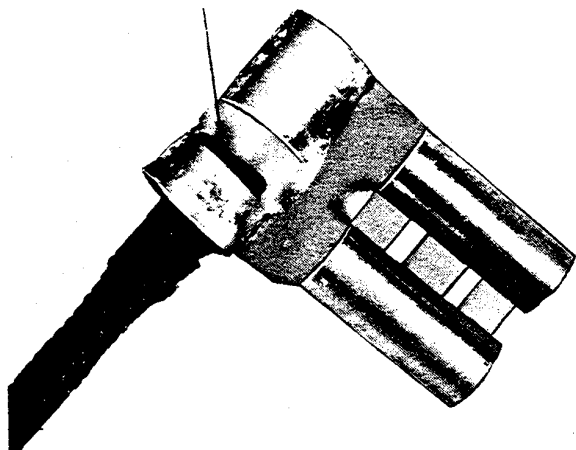
Figure 5

**WIRE STRANDS  
SOLDERED TO TERMINAL**

4. Apply 50/50 or 60/40 solder of the rosin core type to the heated crimp area, feeding the solder in at the open end of the crimp. Stop when molten solder appears in the area between the wire crimp and the insulation crimp. Do not use so much solder that it wicks into the wire within the insulation crimp. A properly soldered flag terminal should appear as shown in figure 5.

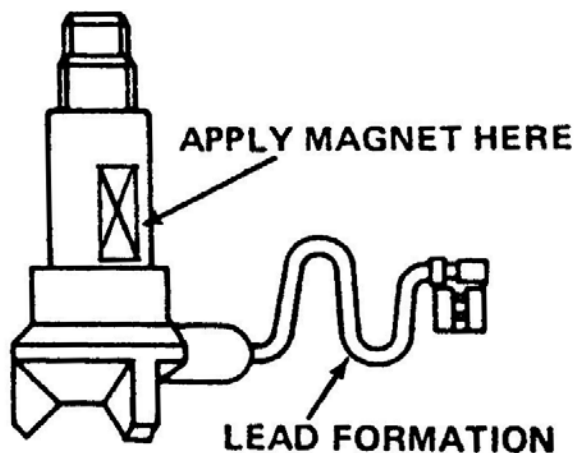
Figure 6

It has been discovered that some D2000 Magneto Capacitors P/N 10-382681 (6 cyl.), 10-382681-1 (8 cyl.) and 10-382807 (4 cyl.) have brass tubular housings. It is recommended that the brass housing capacitors be identified, removed from service and replaced with the steel housed capacitors. (Figure 6 illustrates the method for identifying capacitors with brass housings.)

1. Reinstall the capacitors in the magneto cover forming the leads as shown in figure 6. Torque the capacitor securing nuts to 60-75 inch pounds.
2. An Engine Log Book entry indicating compliance with this bulletin is recommended.

- A. When complying with inspection requirements outlined in Part I also perform a check for housing material of the capacitor as follows:
  1. Using a small magnet, determine if the tubular housing of the capacitor is steel.
  2. Apply the magnet to the housing just above the upper edge of the rubber stabilizing boot as shown in figure 6.

3. If the housing is not magnetic, the housing is brass and the entire capacitor should be replaced with one known to have a steel housing verified by the magnet checks described in 1 & 2 above.
4. Replacement for the brass housing capacitors can be procured through arrangements with recognized
