## ▶ AIRCRAFT

- SUBJECT:** 10-353110 bearing in D-2000/D-2200 Series Magneto.
- REASON FOR BULLETIN:**
- Part 1. To alert users of D-2000/D-2200 Series Magnetos of possible bearing difficulty.
  - Part 2. To provide a procedure for inspection of subject bearing.
- EQUIPMENT AFFECTED:**
- Part 1. D-2000/D-2200 magnetos with Red name plates having Serial Numbers above 3000 and below 17510, (including magnetos identified with the letters "A" or "R" preceding the Serial Number), which DO NOT have the letter "B" stamped in the approximate center of the bottom line on the name plate.

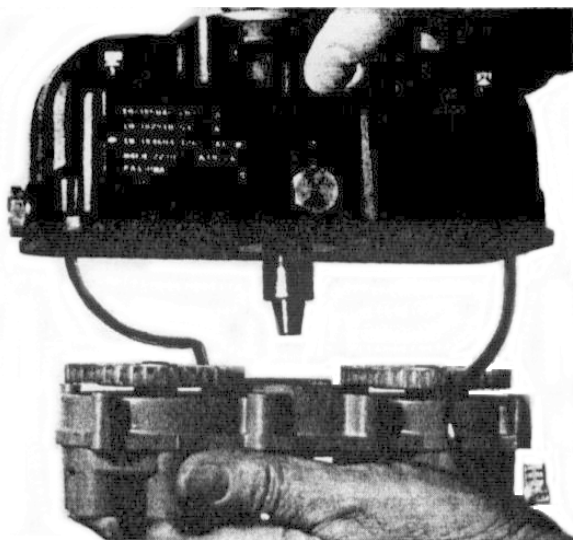
Figure 1.

Field reports indicate that occasionally the magneto rear bearing, Part No. 10-353110, can become overheated. This condition may be the result of a tight bearing fit. To insure a "free" bearing fit, all affected magnetos should be checked as outlined in this bulletin.

Position of magneto for checking free fall test of bearing tolerance.

- D. Prepare a soft surface for the distributor block to drop on or position hand to catch block when it falls from magneto shaft. Invert magneto so drive end is up (See Figure 1) and the distributor block/bearing assembly should drop from the shaft. **Do not side load magneto shaft** by gripping both housing and drive member. Acceptable magnetos should be reassembled in accordance with Bendix Overhaul Manual, Publication Form L-945.

- E. If distributor block does not drop from shaft in step D procedure, insure that block is not sticking by moving the block approximately 1/8 inch away from housing. If block still does not drop from shaft, the bearing must be replaced.
- F. Remove distributor block from magneto and replace the bearing with a new 10-353110 part having "Bendix" identification. The 11-9998 pressing tool and 11-9999 bearing support tool must be used for this procedure.

- G. After the new bearing is installed, repeat the block drop test described in paragraph D and reassemble magneto as noted.
- H. If any magneto still fails the free fall test, install a new distributor block and bearing assembly which has been tested at the factory. These assemblies have the following parts numbers:
