**TELEDYNE CONTINENTAL® AIRCRAFT ENGINE  
CRITICAL SERVICE BULLETIN**

**CSB01-1  
TECHNICAL PORTIONS  
FAA APPROVED**

**SUBJECT: FUEL PUMP INSPECTION and SEAL LEAK TEST**

**PURPOSE: To Provide A Leak Test Procedure to Insure Integrity Of Basic Fuel Pump Fuel Seal on Fuel Pump Assemblies Manufactured Between July 1, 1998 And May 31, 2000.**

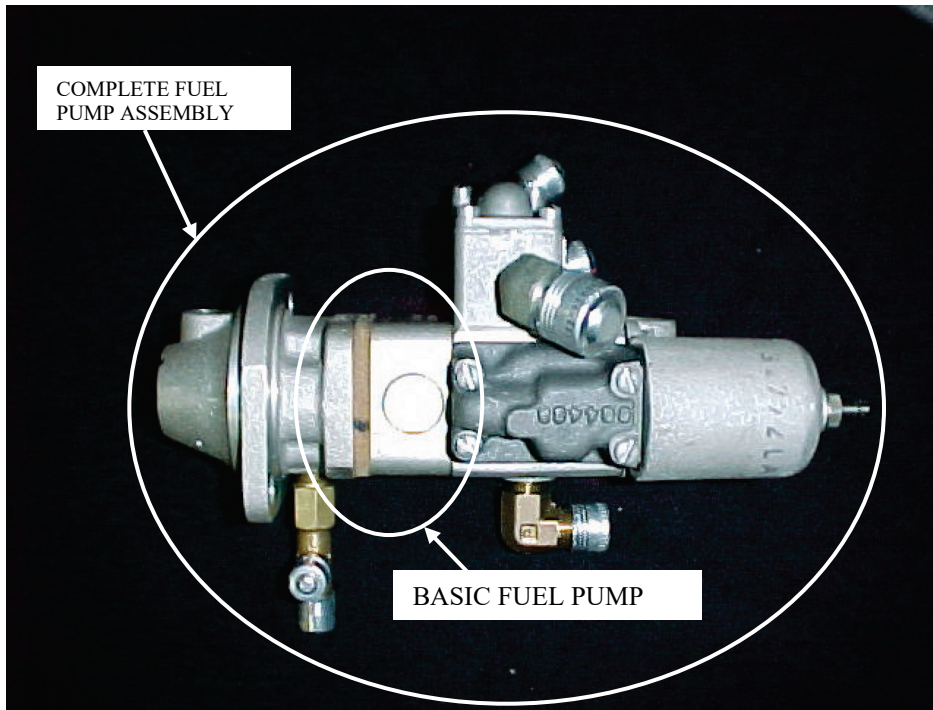
**FIGURE 1  
FUEL PUMP ASSEMBLY COMPLETE  
(TYPICAL)**

**AFFECTED: IO-240, IO-360, IO-346, O-470-G7, O-470-G10, O-470-GCI, IO-470, GIO-470, IO-520, LIO-520, IO-550, GIO-550, LTSIO-360, TSIO-360, TSIO-470, TSIO-520, TSIO-550, TSIOL-550, GTSIO-520 model engines with P.N 642932-1, 2, 3 & 4 basic fuel pump<sup>①</sup> manufactured between July 1, 1998 and May 31, 2000<sup>②</sup>.**

- ① Refer to Figures 1 and 2**
- ② Engines delivered from TCM between July 1, 1998 and November 26, 2000, See GENERAL INFORMATION section of this CSB.**

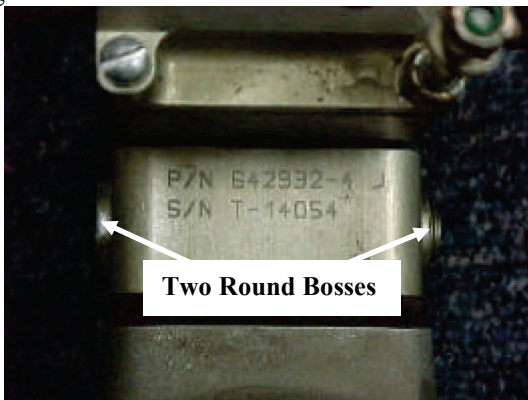
**FIGURE 3**  
**Affected Basic Fuel Pump**  
**P/N's 642932-1, -2, -3, & -4**

Affected engine driven fuel pump assemblies were manufactured utilizing basic fuel pumps P/N's 642932-1, 642932-2, 642932-3 and 642932-4. These basic fuel pumps may be identified by the presence of two (2) round bosses located on opposite sides of the basic fuel pump housing. Refer to Figure 3.

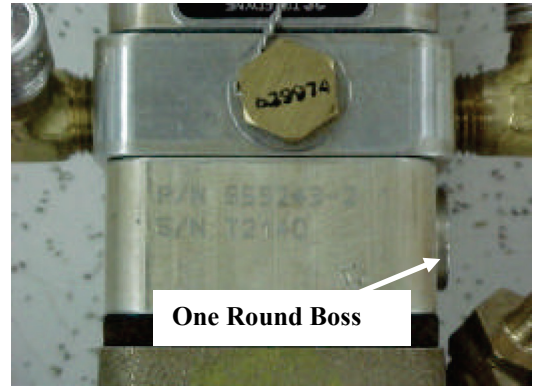
**FIGURE 4**  
**Current Production Basic Fuel Pump**  
**P/N's 655243-1, -2, -3, & -4**  
 (basic fuel pumps with one round boss are not affected by this bulletin)

New basic fuel pumps P/N's 655243-1, 655243-2, 655243-3 and 655243-4 having only one round boss are not affected by this service bulletin. Refer to Figure 4.

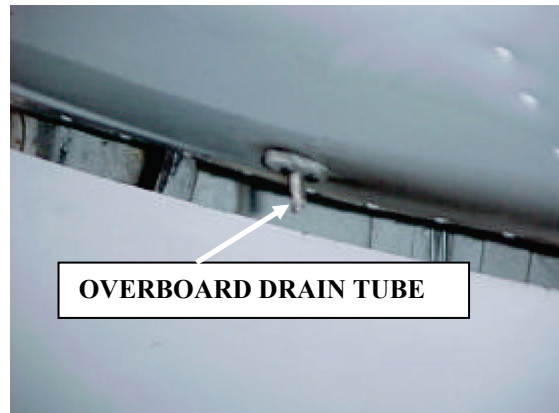
**FIGURE 5**  
**Fuel Pump Overboard Drain Tube**  
**(Typical)**

1. Locate the engine driven fuel pump assembly basic fuel pump seal overboard drain tube that exits the engine lower cowling.

6. Turn the aircraft Master Switch ON.
7. Turn the aircraft electric fuel boost pump ON, to the high position.
8. Have an assistant observe the engine driven fuel pump assembly basic fuel pump seal overboard drain tube for evidence of fuel discharge. See Figure 5.
9. If there is no visible indication of fuel being discharged from the fuel pump assembly basic fuel pump seal overboard drain tube make an engine logbook entry verifying compliance with TCM CSB01-1.
10. If there is visible discharge of fuel from the engine driven fuel pump assembly basic fuel pump seal overboard drain tube proceed to step 11.
11. Locate the engine driven fuel pump assembly basic fuel pump seal drain tube connection at the engine driven fuel pump. Refer to Figure 6.

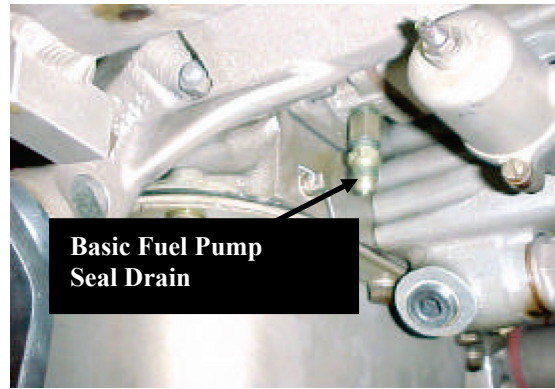
**FIGURE 6**

**Fuel Pump Seal Drain Connection (Typical)**

12. Isolate the basic fuel pump seal drain by disconnecting the seal drain tube at the fitting. Refer to Figure 6.
13. Repeat steps 6 and 7 having the assistant observe the fuel pump assembly basic fuel pump seal drain fitting at the fuel pump assembly for evidence of fuel discharge.
14. If no fuel discharge is noted, reconnect the fuel pump assembly basic fuel pump seal drain tube. Make an engine logbook entry indicating compliance with CSB 01-1.

15. If fuel discharge is noted, proceed to Part B.
