**CONTINENTAL MOTORS INC<sup>®</sup> AIRCRAFT ENGINE**  
**CRITICAL SERVICE BULLETIN**

**CSB12-1**

**SUBJECT: P/N 641909 Lock Plate Inspection**

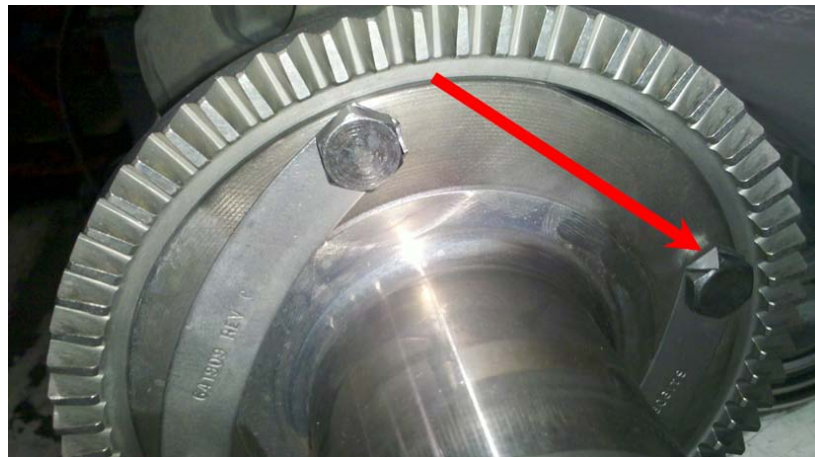
Figure 2.  
Example of  
Bent Tabs

*Compliance with this Bulletin is required to prevent the Possible Loss of Torque of Face Gear Attach Screws and Subsequent Engine Failure*

1. Assure that both magnetos are properly grounded and ignition switch is in the **OFF** position
2. Assure that mixture control is in idle **CUTOFF**
3. Assure that the fuel selector is in the **OFF** position
4. Open or remove cowling to gain access to all upper sparkplugs and left hand crankcase forward of number six cylinder
5. Remove upper spark plugs installed in all cylinders to allow hand rotation of engine
6. Remove lock wire, hex plug p/n 532432, and copper gasket p/n MS35769-11 (discard gasket) as shown in Figure 1.
7. Using suitable bore scope, or inspection light, view alternator face gear attachment screws, 4 each p/n 649205
8. Inspect attach screw lock plates p/n 641909 to ensure tab is bent against head flat of attach screws as shown in Figure 2. Engine will require hand rotation to view tab bending at each attach screw location.
