**CONTINENTAL MOTORS® AIRCRAFT ENGINE
CRITICAL SERVICE BULLETIN**

**CATEGORY 2
CSB17-08**

SUBJECT: Hartzell Engine Technologies (HET) Alert Service Bulletin (ASB) No. 074

Turbocharger Center Housing Inspection

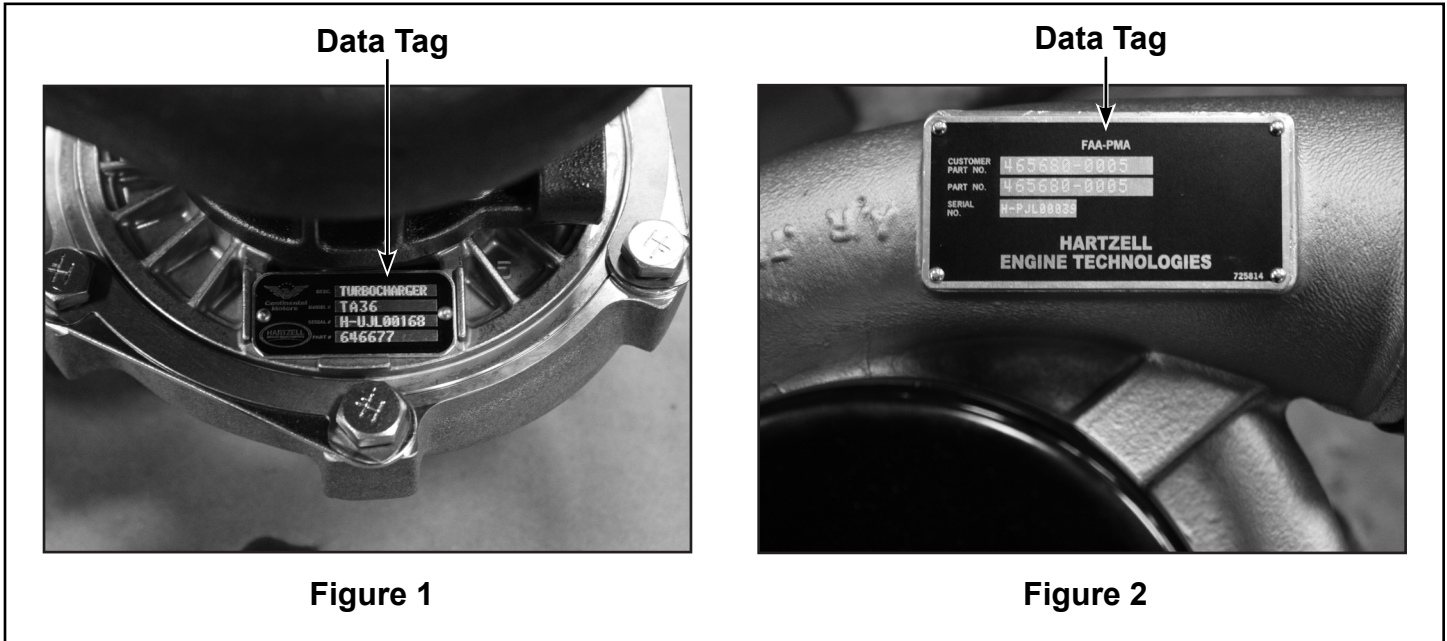
Turbocharger Data Tag Locations
Figures 1 & 2

NOTE : The turbocharger data tag can be found in one of two locations depending on model. Refer to Figures 1 & 2 for locations.

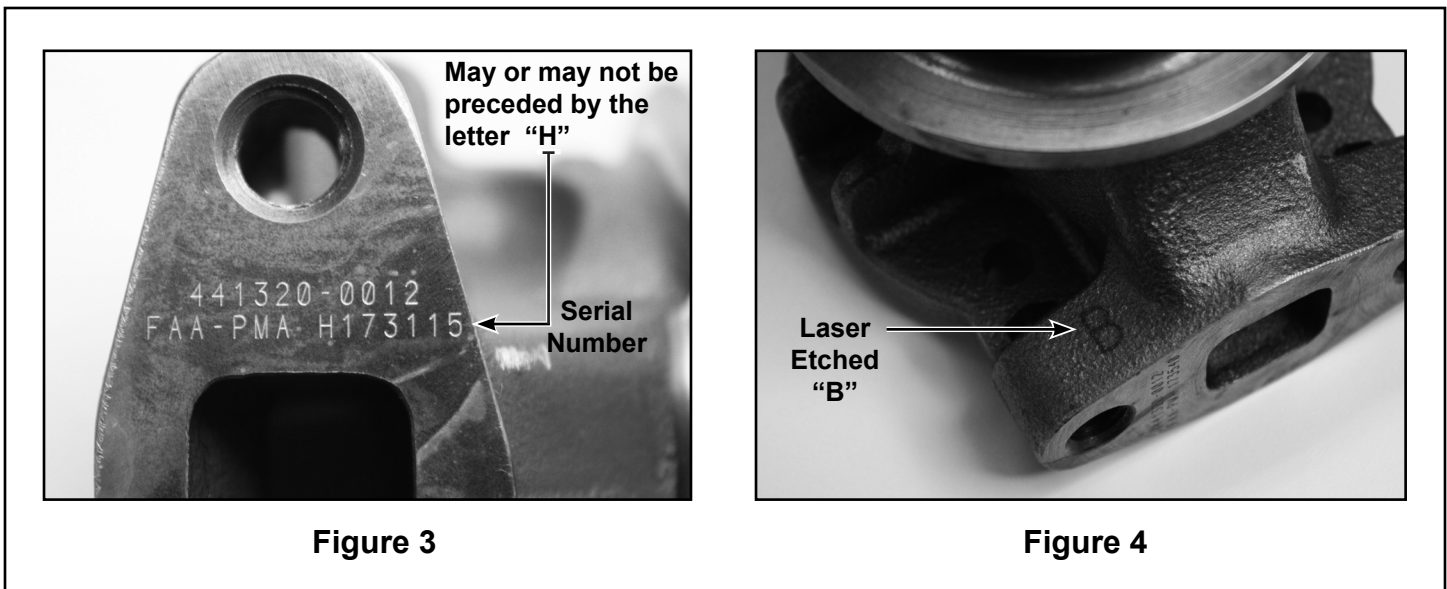
Turbocharger Center Housing Oil Drain (lower) Flange
Figures 3 & 4

- (3) If the turbocharger was serviced between 10 May, 2017 and the effective date of this ASB, and effectivity cannot be established from the maintenance records, utilize the applicable aircraft maintenance manual to gain access to and remove the turbocharger center housing oil drain line from (lower) flange. Inspect turbocharger center housing serial number against affected serial numbers found in Table 2 of this ASB. (See Figure 3 for serial number illustration)

NOTE: Serial numbers found in Table 2 may or may not be preceded by the letter “H” as shown in Figure 3.

- (1) Affected turbochargers and/or center housings
 - (a) Replace turbocharger center housing with one not associated with this ASB.
 - 1 Replacement center housing may be new or factory reworked.
 - 2 Factory reworked center housings will be identified by a laser etched “B” located on the side of the oil drain flange (See Figure 4).
