CONTINENTAL AEROSPACE TECHNOLOGIES™
CRITICAL SERVICE BULLETIN

CATEGORY 2
CSB23-04

Alert Service Bulletin No. 097

Alternator Mounting Flange Inspection

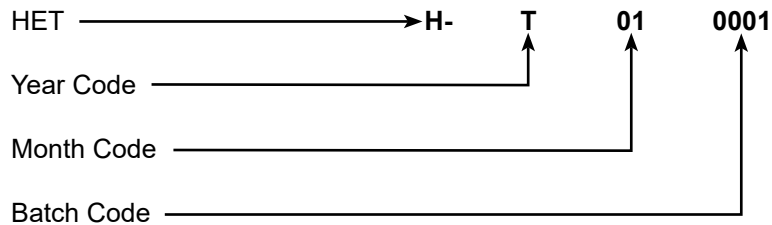
a) Serial Number Identification for H-T thru H-X:

Example above: T=2019, 01=January, 0001=first unit of the month (batch). The year code advances one letter in alphabetical order for each succeeding year. X012176: X=2023, 01=January.

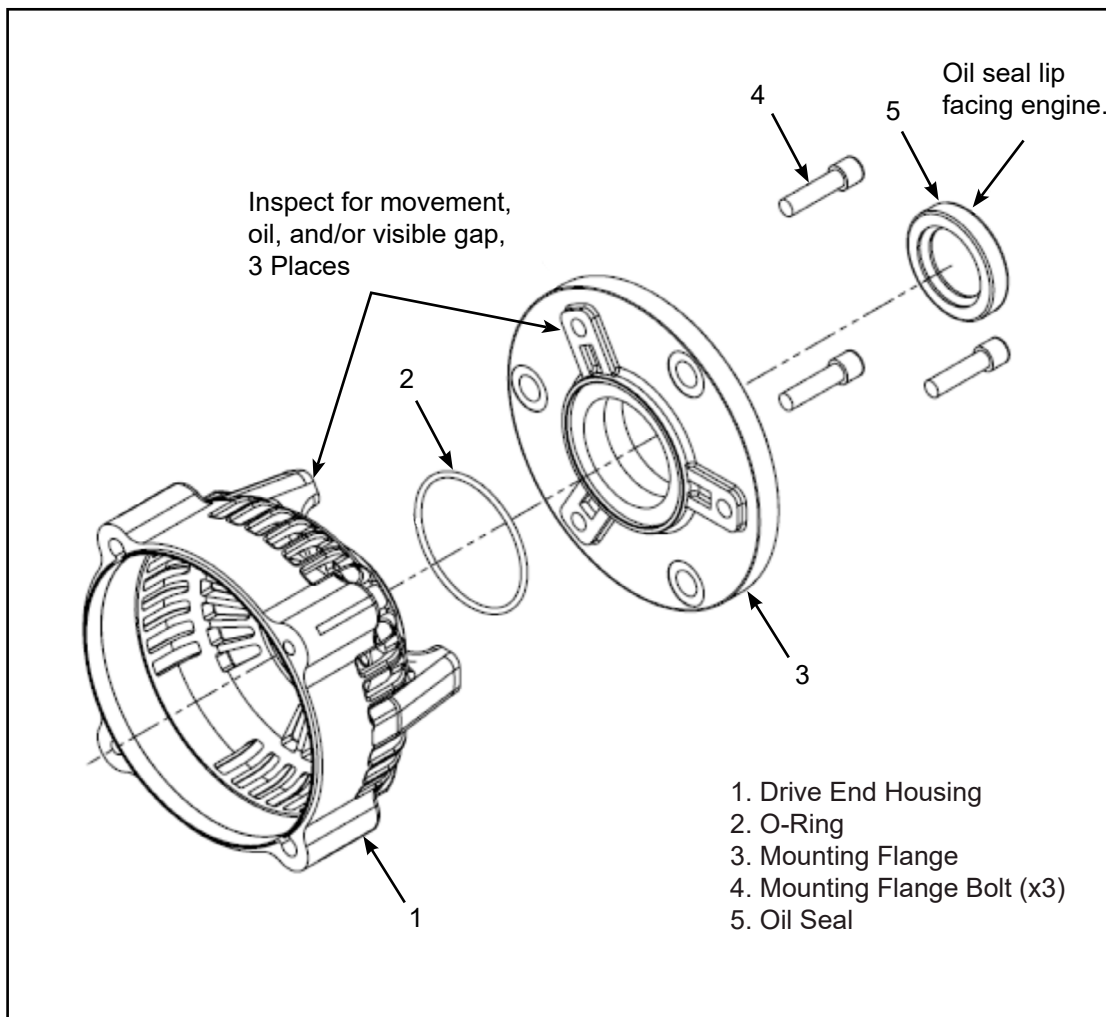
Figure 1 - Alternator Mounting Flange

- (1) Hartzell Engine Tech has discovered that alternator P/Ns referenced in 1.A. may experience a reduction in clamping force at the joint between the alternator drive end housing (1) and mounting flange (3).
 - (a) Loss of alternator mounting flange clamping force may result in loss of engine oil and/or unexpected loss of engine power.
- (2) This ASB is to advise the field of a known condition and to supply inspection criteria to identify affected alternators.

- (1) If a loose condition or oil leak is **not** found
 - (a) Remove affected alternator per applicable aircraft engine and airframe service instructions or maintenance manual.
 - (b) Remove and discard one of three flange bolts (4) securing the alternator to the mounting flange.
 - (c) Apply a mild solvent to a non-metallic bristle brush and remove oil/grease and any cured threadlocker present in the drive end housing threads. Ensure debris does not enter the alternator housing.
 - (d) Apply LOCTITE® 272 threadlocker to one of three drive end housing (1) threads and install one new flange bolt (4) to snug condition.
 - (e) Repeat steps (b) thru (d) for remaining two flange bolts.

- (f) Torque alternator mounting flange bolts to 85-90 in-lbs.
 - (g) Inspect alternator drive coupling per manufacturer's instructions.
 - (h) Install the alternator onto the engine per applicable aircraft engine and airframe service instructions or maintenance manual. Continue to 3.C, Return to Service.

- (b) Remove the alternator drive coupling from the alternator per manufacturer's instructions.
 - (c) Remove and discard three mounting flange bolts (4) and separate the mounting flange (3) from the alternator drive end housing (1).

- (m) Install the alternator mounting flange (3) onto the alternator drive end housing (1). Secure with three new mounting flange bolts (4) to snug condition.
