**CRITICAL SERVICE BULLETIN**

**CSB26-04**TECHNICAL PORTIONS  
FAA ACCEPTED

**SUBJECT:** Inspection, Removal and Replacement of Affected Oil Sumps, P/N 652423

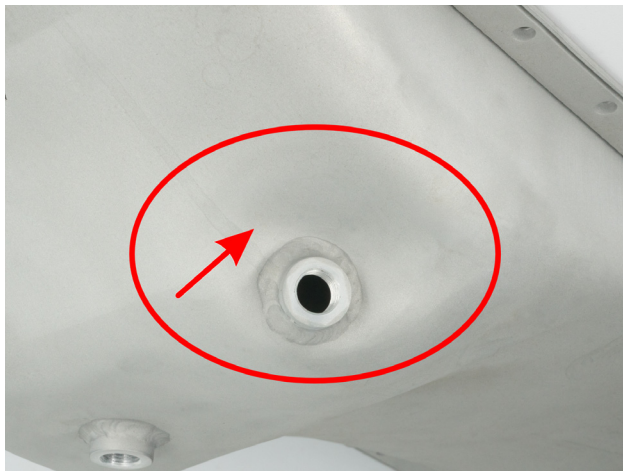
Figure 1. Unaffected Oil Sump Design

- Determine whether the oil sump is the unaffected or affected design according to Section III.
- If the oil sump is the unaffected design shown in Figure 1, no further action is required. Record the inspection and compliance with CSB26-04 in the engine logbook.

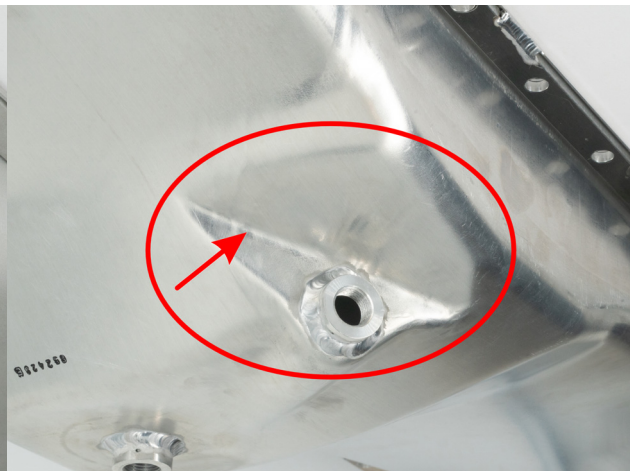
Figure 2. Affected Oil Sump Design

Use the following figures to determine whether Part No. 652423 is of the unaffected or affected design. The affected oil sump can be identified by a tight radius above the drain boss.

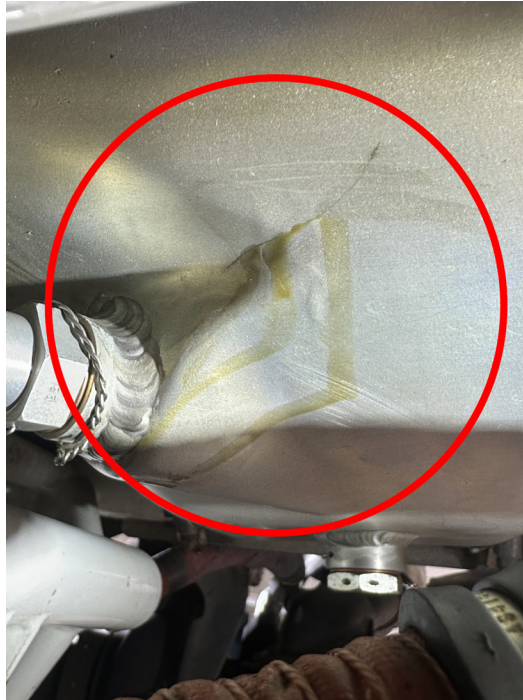
**Figure 3. Affected Oil Sump Inspection Area**

Continental discovered Part No. 652423 oil sumps shipped on engines or as spares between September 24, 2025 and April 29, 2026 may be prone to fracturing and leaking oil as shown in Figure 3. For engines or replacement parts acquired during this time frame, removal and replacement of Part No. 652423 may be required. A list of engines assembled with oil sumps, Part No. 652423 follows this section.

- If the oil sump is the affected design shown in Figure 2, inspect the area circled in Figure 3 for any visible cracks without magnification. It is permissible to use a borescope or other flexible scope for visual inspection of the area.
- If no cracks are found, the oil sump may remain in service; repeat this inspection at intervals not to exceed 10 flight hours until the affected oil sump is replaced according to instructions in Section V.
- If any cracks are found, replace the oil sump according to the instructions in Section V before further flight.

1. Remove the engine according to the instructions in the aircraft's primary Instructions for Continued Airworthiness (ICA).
2. Remove the oil sump from the engine according to the instructions in Chapter 12 of the engine's primary ICA (see Table 4).
3. Install an unaffected oil sump onto the engine according to the instructions in Chapter 17 of the engine's primary ICA.
4. Install the engine according to the instructions in the aircraft's primary ICA.
5. Record the installation of oil sump and compliance with CSB26-04 in the engine logbook.
