CRITICAL SERVICE BULLETIN

CSB93-13

SUBJECT: CARBURETOR AIR INTAKE HOUSING ASSEMBLY INSPECTION

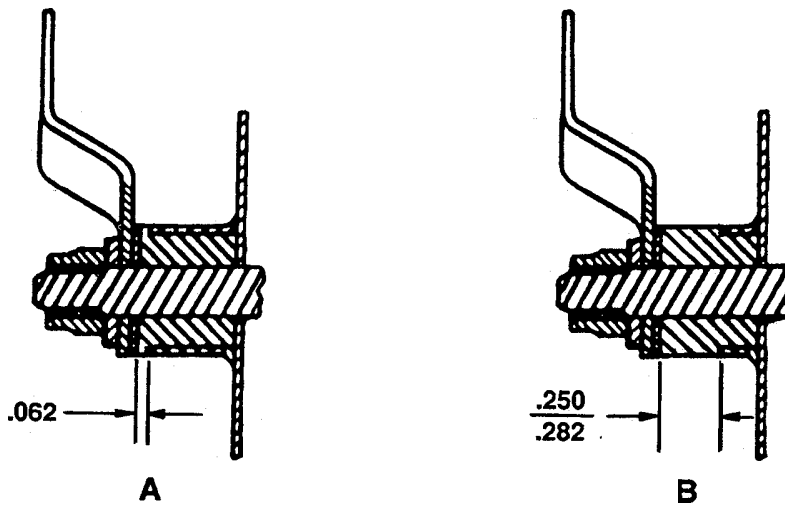
FIGURE 1
DETAIL OF BEARING AND HOUSING

1. Remove engine cowling to gain access to the carburetor air intake housing assembly.
2. Measure the exposed portion of the Teflon bearing. See Figure 1.

- A. Those carburetor air intake housing assemblies having an exposed portion of the Teflon bearing which measures .062 (as shown in Figure 1 A) do not require replacement pursuant to this bulletin. However, such assemblies should be inspected thoroughly as part of each 100 hour inspection and any discrepancies corrected.

- B. Any carburetor air intake housing assembly having an exposed portion of the Teflon bearing which measures .250 - .282 (as shown in Figure 1 B) must be inspected in accordance with this bulletin, with repetitive inspections at 25 hour intervals until the assembly is replaced.

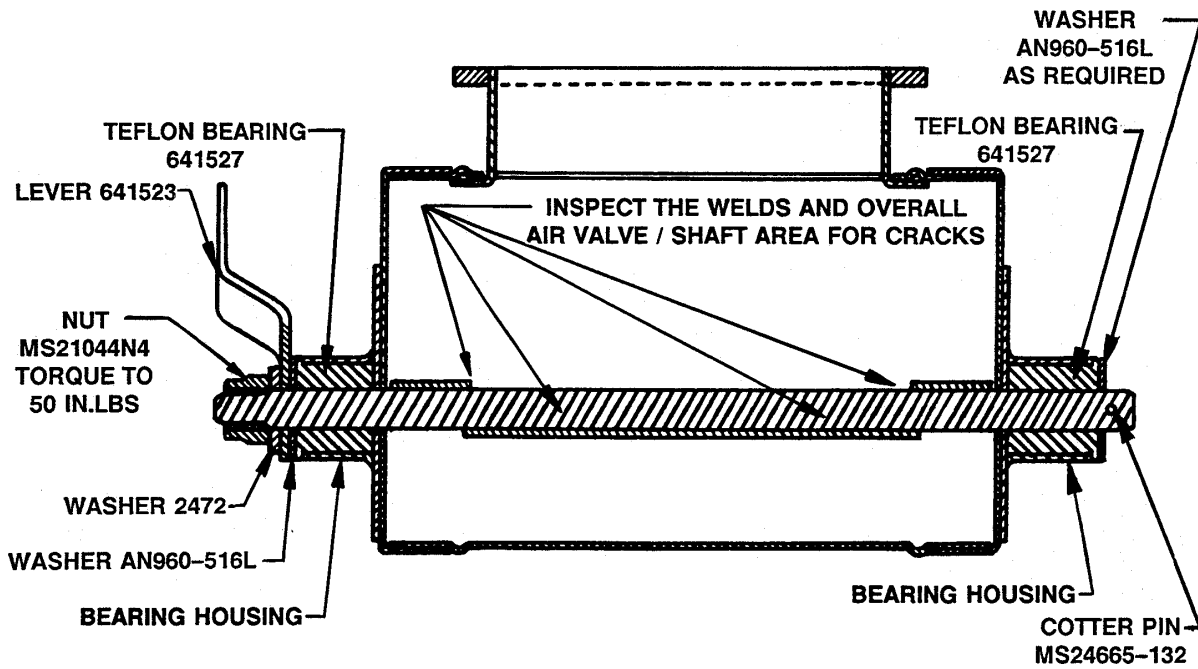
FIGURE 2
CROSS-SECTION OF AIRBOX

TCM has received reports that the affected carburetor air intake housing assemblies have experienced cracks in the air valve and in the welds which attach the air valve to the shaft. Therefore, it is necessary to inspect and replace the affected assemblies in accordance with the following instructions. Affected repair kits P/N 641689 must be replaced with current production kits.

3. Remove the air filter so that the air valve and the welds that attach the air valve to the shaft can be inspected.
4. Inspect the entire carburetor air intake housing assembly for cracks. Using an inspection mirror and light, thoroughly inspect the welds that attach the air valve to the shaft and the areas of the air valve adjacent to the welds for cracks. See Figure 2.

REPLACE THE COMPLETE CARBURETOR AIR INTAKE HOUSING ASSEMBLY BEFORE FURTHER FLIGHT IF CRACKS ARE FOUND ANYWHERE IN THE ASSEMBLY.
