**TELEDYNE CONTINENTAL® AIRCRAFT ENGINE
CRITICAL SERVICE BULLETIN
Compliance Necessary To Maintain Safety**

CSB97-9

SUBJECT: GTSIO-520 CRANKCASE INSPECTION

PURPOSE: PROVIDES INSTRUCTIONS FOR CRANKCASE INSPECTION AND REMOVAL OF NUMBER 5 CYLINDER 7TH STUD RETAINING BRACKET

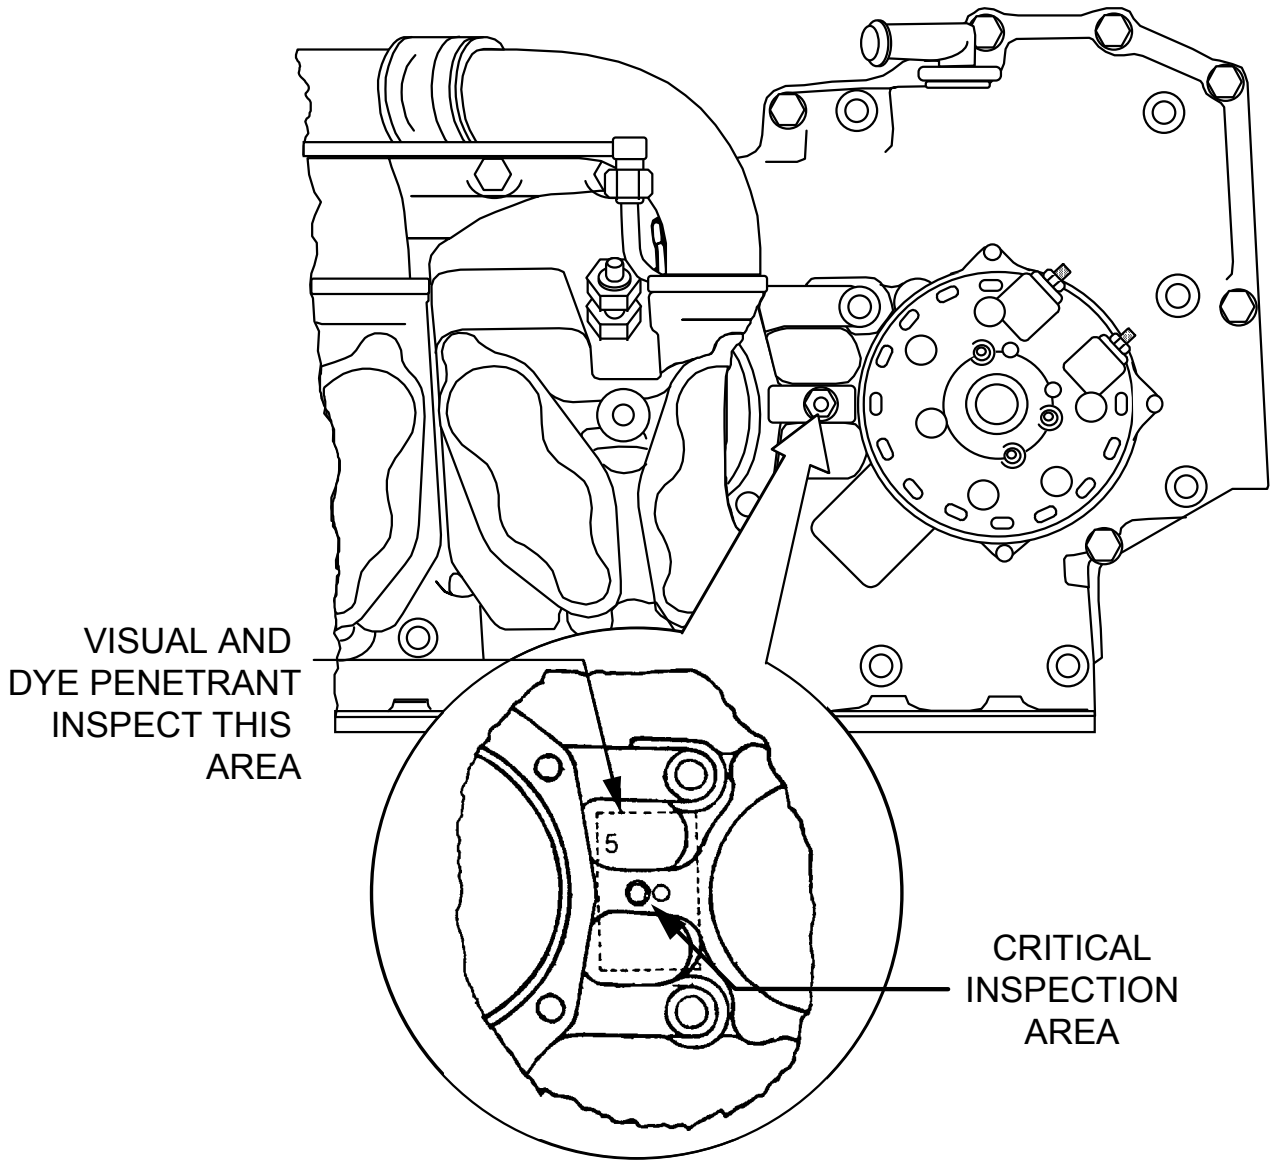
Inspection of engines and crankcases returned to TCM has identified the possibility of a crankcase crack developing in the area of the number 5 cylinder 7th stud and aft (9 o'clock) alternator mounting stud.

Within the next 25 operating hours after the effective date of this bulletin and every 50 hours for the next 500 hours of operation perform a visual and dye penetrant inspection of the engine crankcase at the number 5 cylinder 7th stud location. Refer to Figure 1 for area to be inspected.

1. Clean the area around and adjacent to the number 5 cylinder 7th stud and alternator (Refer to Figure 1) with an approved cleaner.
2. Perform a visual and dye penetrant inspection of the area, with specific attention to the area between the number 5 cylinder 7th stud and the aft (9 o'clock) alternator mount stud (Refer to Figure 1).

3. If a crack is identified, the crankcase or engine must be replaced prior to further operation.
4. If no crack is identified, comply with the following instruction prior to returning the engine to service.
