CONTINENTAL MOTORS® AIRCRAFT ENGINE
CRITICAL SERVICE BULLETIN
 Compliance Necessary to Maintain Safety

CSB99-6B
 Supersedes CSB99-6A
 TECHNICAL PORTIONS
 FAA APPROVED

SUBJECT: GTSIO-520 & GIO-550 CRANKSHAFT INSPECTION

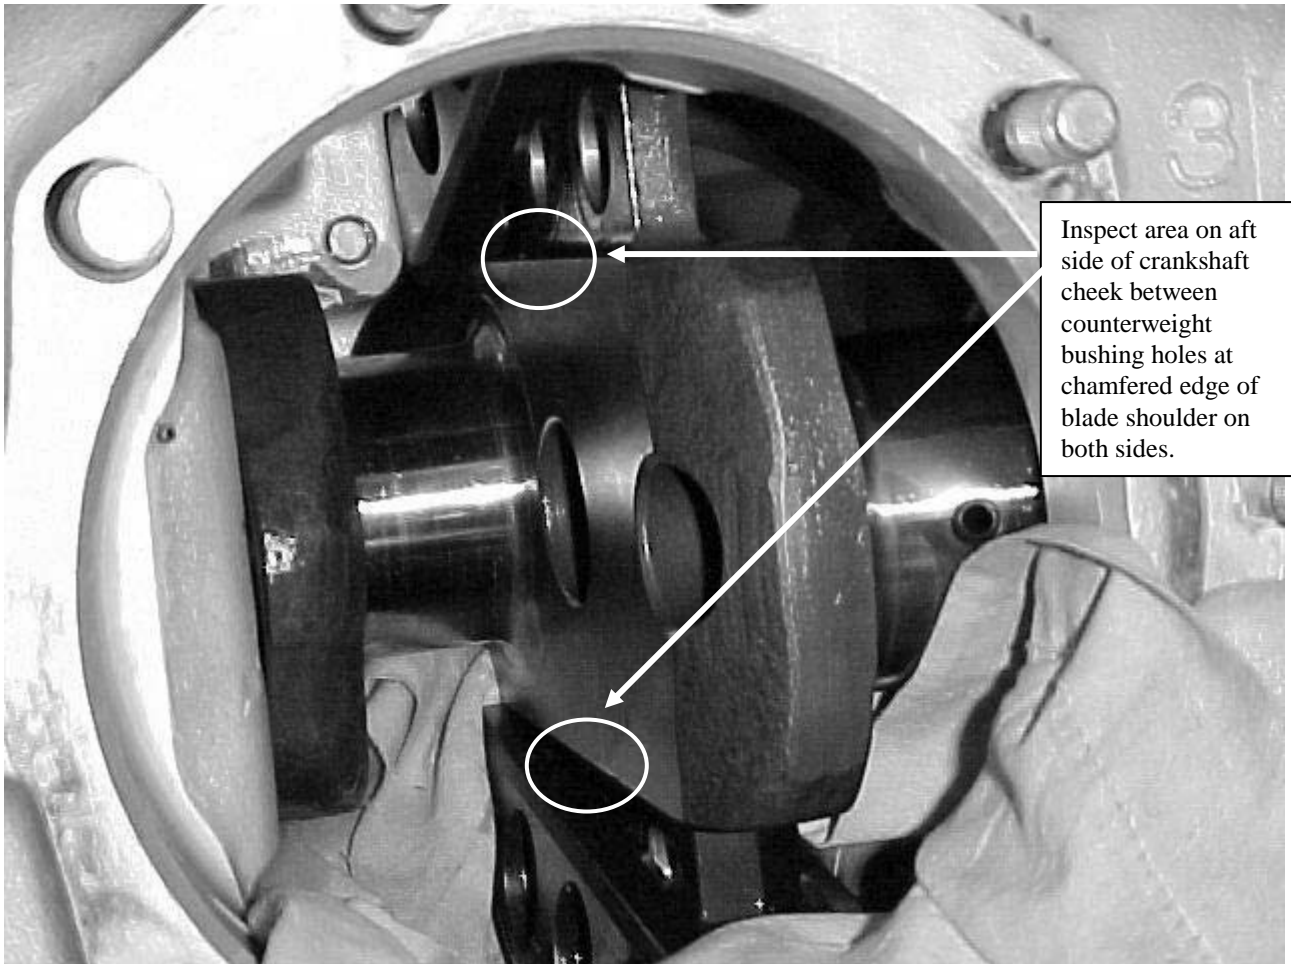
5. Using a flashlight and mirror or a borescope visually inspect the aft side of the number two crankshaft cheek for indications of a crack or mechanical damage. The inspection area is between the counterweight blade bushing holes at the chamfered edge of blade shoulder on both sides of the crankshaft cheek aft face. See Figure 4.

FIGURE 4
COUNTERWEIGHTS POSITIONED FOR VISUAL AND ULTRASONIC INSPECTION
(VISUALLY INSPECT CIRCLED AREA FOR CRACK INDICATIONS)

1. Rotate the crankshaft so that the crankshaft cheek to be inspected is positioned as shown in Figure 4. The crankshaft connecting rod journal will be at the 8 o'clock position and the counterweight hanger blades will be at the 11 o'clock and 5 o'clock positions.

6. If visual inspection reveals a crack the engine must be removed from service until repaired or replaced.
7. If the visual inspection does not clearly reveal a crack, perform an ultrasonic inspection of the aft side of the number two crankshaft cheek in accordance with Section "B" ULTRASONIC INSPECTION.
