## SERVICE BULLETIN

**SUBJECT:** Recommended Replacement of AEL12892 Thrust Buttons

**AFFECTED:** Continental Aerospace Technologies OX-320, IOX-320, OX-340, OX-340-CC, IOX-340, OX-360, IOX-360, OX-370, IOX-370, OX-540, IOX-540, VA540 Titan™ experimental aircraft engines

**DOC NO** REVISION  
E-SB007

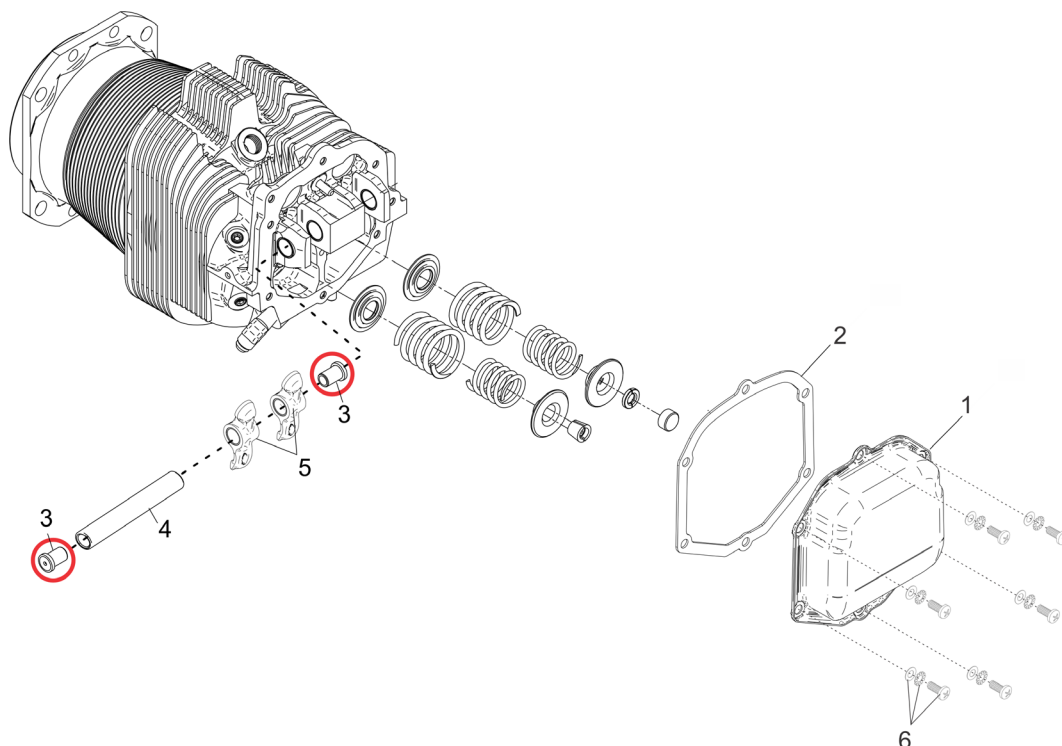
**Figure 1.**

Continental has been made aware of a potential incorrect material in the AEL12892 thrust button that could accelerate wear. Parts shipped from Continental from 12/25/2023 to 03/11/2026 could be affected. Verify the 8130-3 tag for ship dates.

If signs of overheating or accelerated wear of the thrust button (3) are found, ensure that no debris is present in the cylinder drain back line, oil sump, or in the rocker box area and contact Continental. If none are found, proceed to step 4

1. Disconnect power to engine.
2. Make sure engine is cool.
3. Remove the rocker cover (Figure 1) (1) and gasket (2) from the cylinder assembly. Discard the gasket (2).

4. Remove the thrust buttons (3). Removal of the shaft (4) and rockers (5) is not required.
5. Replace both thrust buttons (3) regardless of condition.
6. Install the rocker cover (1) with a new gasket (2) on the cylinder assembly.
7. Install and torque hardware (6) to the value specified in the engine's primary Instructions for Continued Airworthiness (ICA).
8. Enable power to the engine.
9. Complete the "Operational Ground Check" per the engine's primary ICA.
10. Make an appropriate entry in the engine logbook.

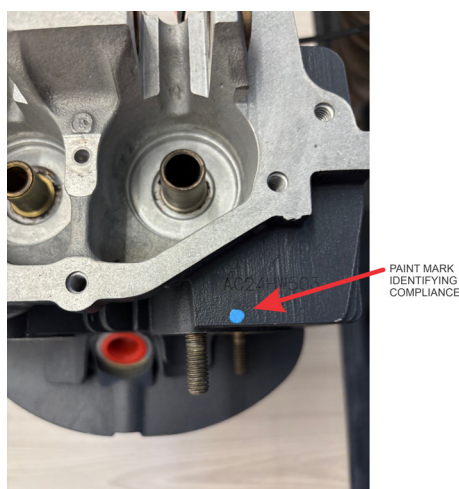
**Figure 2.**

Continental has verified the material on some cylinders at our distributor's facility. The paint mark shown in Figure 2 identifies compliance. If this mark is on the cylinder, no further action is required.
