# service bulletin

M73-13  
FAA-DER Approved

SUBJECT: Reaming and Bushing Rocker Shaft Bosses

MODELS AFFECTED: A65, A75, C75, C85, C90 O-200, O-300 and GO- 300.

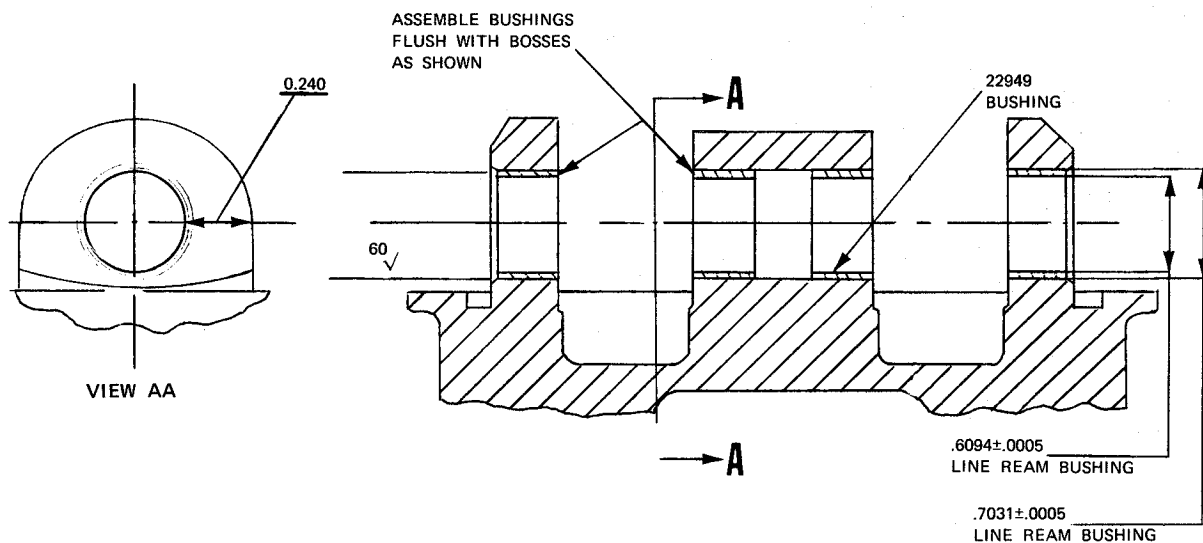
This method of repairing worn rocker shaft bosses on subject engine cylinder assemblies, is possible and recommended providing there is adequate stock in the wall at the center boss.

1. The minimum boss wall thickness measured at the edge of the center boss prior to any reaming and bushing must be .240 inch to be acceptable.
2. If the thickness of the center boss falls within this dimension, the bosses may be reamed. The center boss wall thickness must again be measured after reaming. If it is below .18 inch in any area, the cylinder must not be bushed and should be retired from service.
3. We cannot overstress the importance of producing a smooth finish on the inside diameter of the cylinder bosses when reaming prior to installation of the bushings. Too rough a surface bore finish can contribute to boss breakage. The bore surface roughness should not exceed 60 RMS.
