service bulletin

M78-3

January 11, 1978

SUBJECT: GOVERNOR OIL TRANSFER COLLAR SLEEVES, RETAINING CLIPS AND CLEARANCES

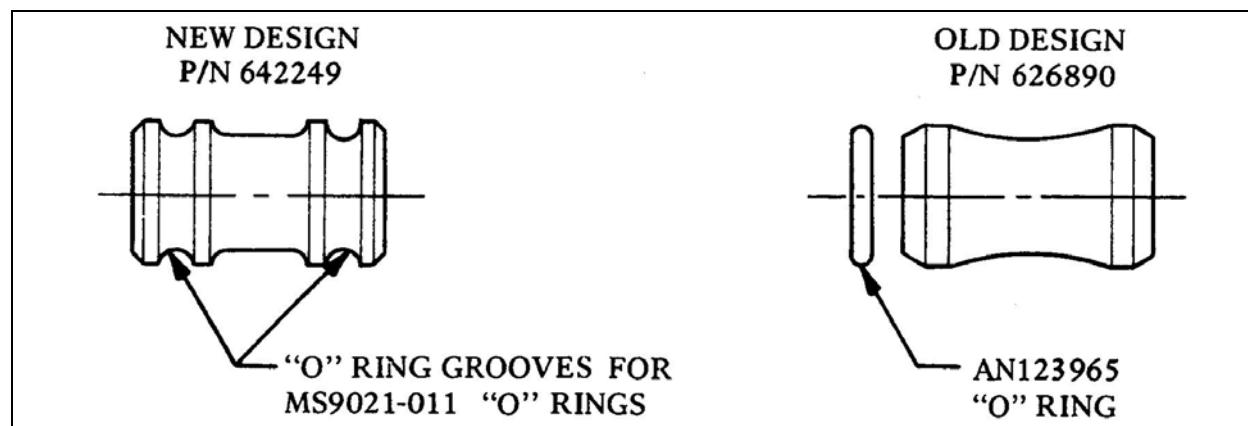
**FIGURE 1**

The Teledyne Continental Motors Aircraft Service Department is pleased to announce the availability of an improved governor oil transfer sleeve TCM part number 642249 to be used with two (2) each MS9021-011 "O" rings (as shown in Figure 1) in all of the above mentioned model engines which incorporate TCM part number 626739 governor oil transfer collar assembly. These parts replace transfer sleeve part number 626890 and "O" ring part number AN123695.

Installation of the new sleeve and "O" ring assembly is recommended at the next overhaul period to reduce the possibility of governor oil leakage between the crankcase and transfer collar assembly.

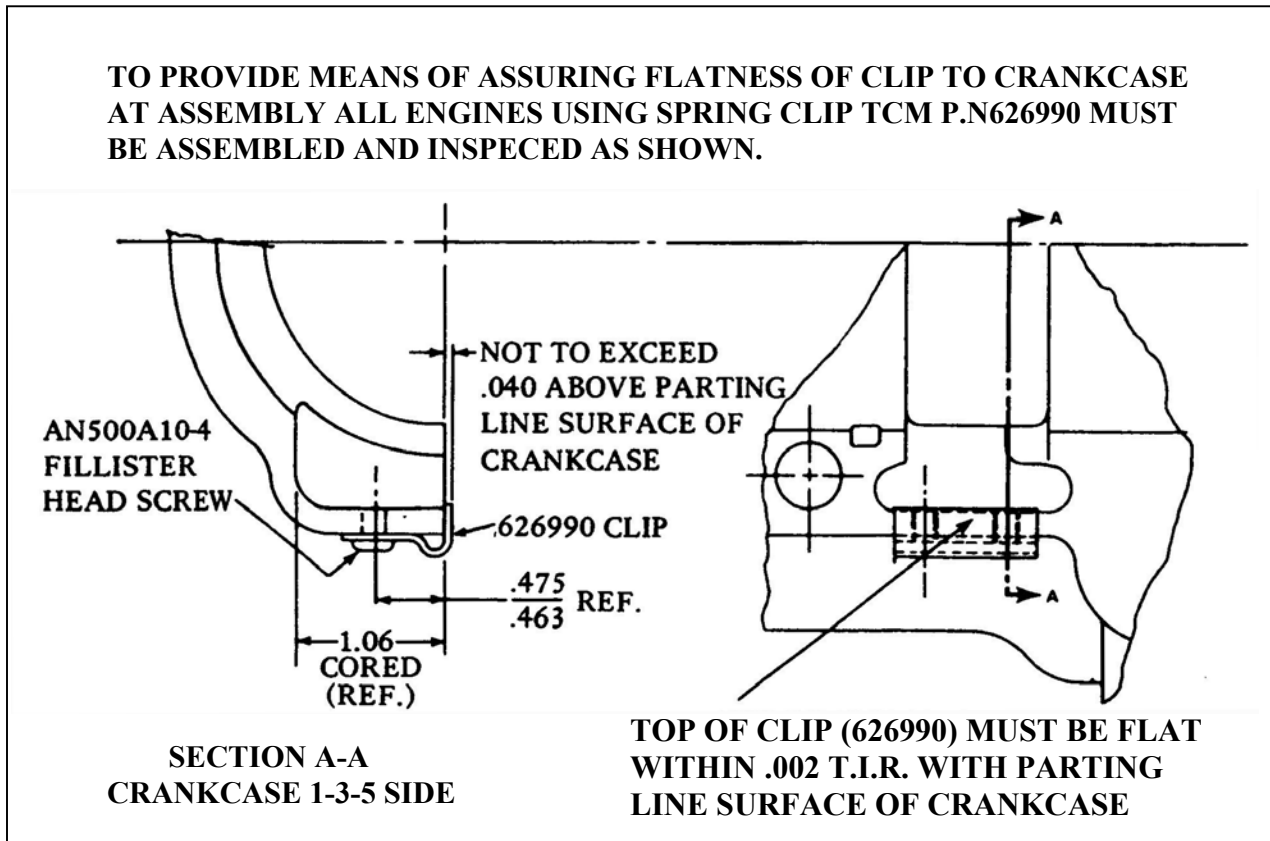
FIGURE 2

CAUTION: Early design crankcases which incorporate the 90 degree transfer collar spring clip TCM part number 626990 as shown in Figure 2 must continue to use that clip with the following caution:

If the transfer collar spring clip is assembled to the crankcase in an excessively raised position, it can cause loading of the transfer collar into the crankshaft resulting in collar scoring and loss of governor control.

To provide a means of assuring flatness of this clip to the crankcase at assembly, inspect and maintain the tolerance as shown in Figure 2. If the required tolerance cannot be attained by tapping the clip with a plastic hammer, discard the clip and select another.
