MANDATORY service bulletin

M87-26

SUBJECT: PISTON PIN REPLACEMENT AND THRU BOLT TORQUE CHECK

AFFECTED: TSIO520CE - This engine is used on the Cessna P210 and T210 Aircraft
S/N 530001 through 530140

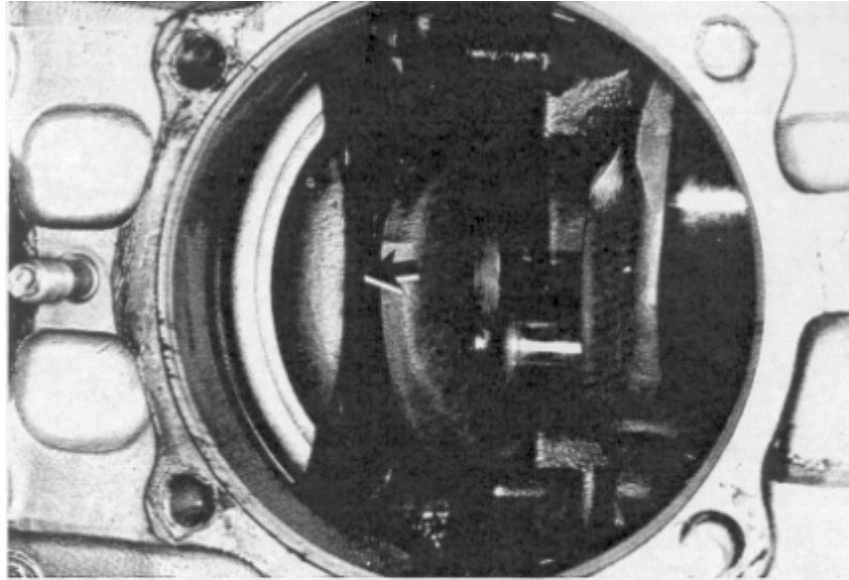
FIGURE A

Figure A depicts how bearing should generally appear.

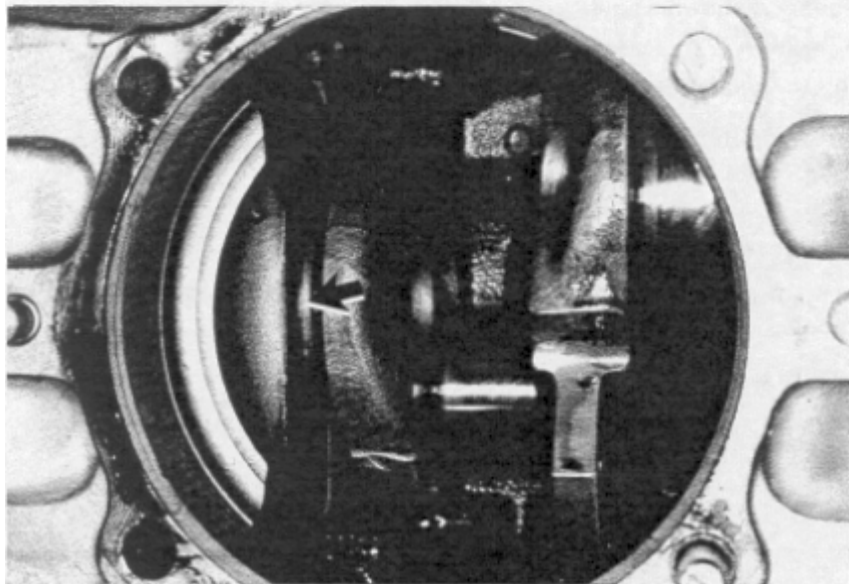
Figure B depicts a bearing that has shifted.

NOTE...Contact your local Teledyne Continental Motors representative (See Page 4) for disposition of any bearing appearing as in Figure B or with any signs of crankcase material distress.
