service bulletin

M87-8

26 February 1987

SUBJECT: **EXHAUST VALVE INSPECTION**MODELS
AFFECTED: **Part I****Rebuilt Engines Only**

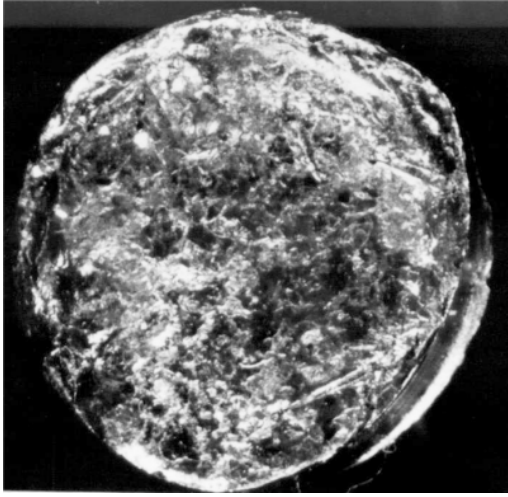
TCM has received and verified a report of exhaust valve P/N 639283 coming loose from its retaining keys. This action was due to the valve tip not having the proper hardness. The reported valve has been traced to a limited number shipped from our vendor. Only a very small number of the valves shipped are suspected of improper hardness. This condition allows the valve tip to wear at an accelerated rate and could lead to valve failure and/or ultimate engine failure. The following action must therefore be taken.

1. Remove the exhaust rocker cover.
2. Visually inspect the exhaust valve tip for abnormal wear. See Example A and B (abnormal wear).

3. If a valve with abnormal wear is located, please contact Teledyne Continental Motors.
4. If upon completion of the inspection or inspections explained in the COMPLIANCE REQUIREMENT section of this bulletin no valves with abnormal wear are noted, reinstall the rocker cover using a new gasket P/N 632310 and make appropriate logbook entry as to compliance with this service bulletin.

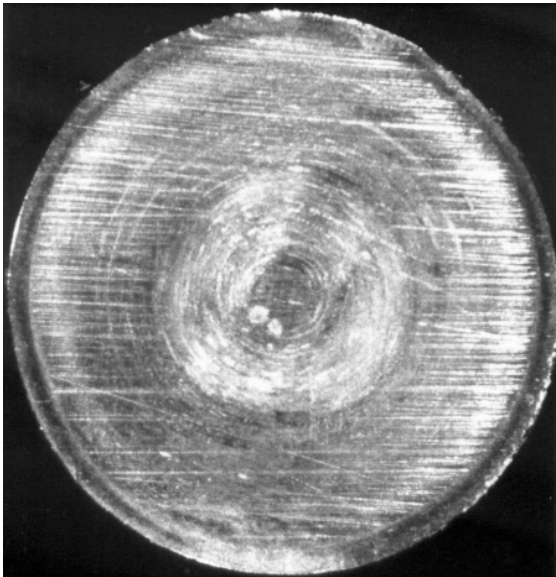
NOTE: If wear is normal, the valve tip should appear similar to Example D (new, unused) or Example C (used, normal wear), depending on hours in use. Valves having improper hardened tips are very soft, so that abnormal wear is readily distinguishable.
