## SERVICE BULLETIN

**SUBJECT:** Recommended Replacement of AEL12892 Thrust Buttons  
**PURPOSE:** To notify customers of a potential incorrect material  
**COMPLIANCE:** At next oil change for parts installed on an engine. For spares, prior to installation

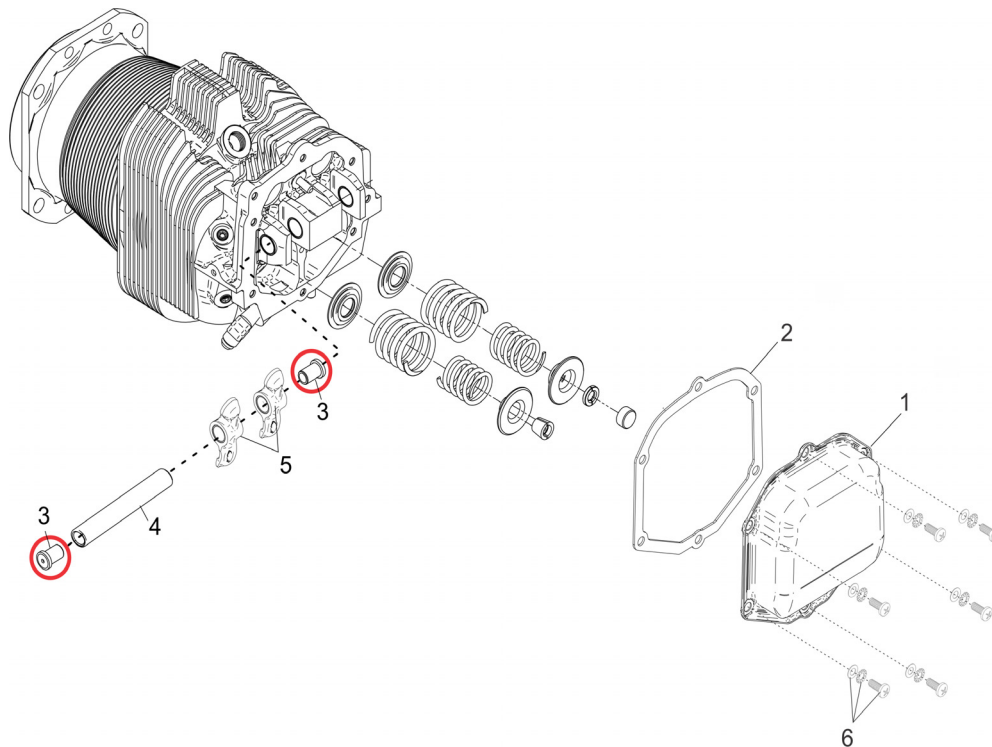
Figure 1.

Continental has been made aware of a potential incorrect material in the AEL12892 thrust button that could accelerate wear. Parts shipped from Continental from 12/25/2023 to 03/11/2026 could be affected. Verify the 8130-3 tag for ship dates.

If signs of overheating or accelerated wear of the thrust button (3) are found, ensure that no debris is present in the cylinder drain back line, oil sump, or in the rocker box area and contact Continental. If none are found, proceed to step 4.

1. Disconnect power to engine.
2. Make sure engine is cool.
3. Remove the rocker cover (Figure 1) (1) and gasket (2) from the cylinder assembly. Discard the gasket (2).

4. Remove the thrust buttons (3). Removal of the shaft (4) and rockers (5) is not required.
5. Replace both thrust buttons (3) regardless of condition.
6. Install the rocker cover (1) with a new gasket (2) on the cylinder assembly.
7. Install and torque hardware (6) to the value specified in the engine's primary Instructions for Continued Airworthiness (ICA).
8. Enable power to the engine.
9. Complete the "Operational Ground Check" per the engine's primary ICA.
10. Make an appropriate engine logbook entry to document compliance with SB017.

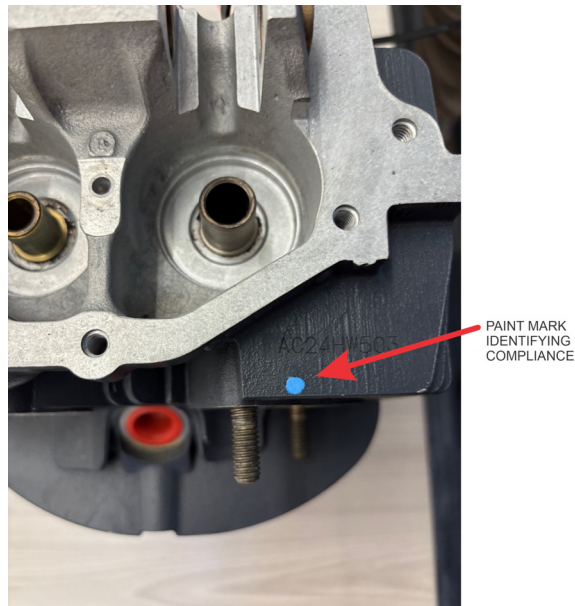
**Figure 2.**

Continental has verified the material on some cylinders at our distributor's facility. The paint mark shown in Figure 2 identifies compliance. If this mark is on the cylinder, no further action is required.
