TELEDYNE CONTINENTAL ® AIRCRAFT ENGINE
SERVICE BULLETIN

SB09-5

SUBJECT: Volare Carburetors, LLC SB4 Service Bulletin, Carburetor Bowl to Float Clearance

Subject: BOWL CLEARANCE – MA- SERIES CARBURETORS

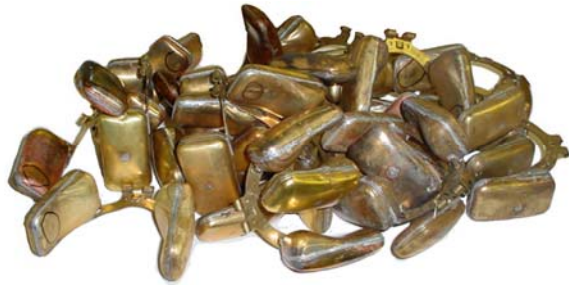
1. **Reasons:** **Warning:** **Failure to follow this advice may result in engine malfunction, damage, injury or death.** Reports of sticking, leaking and/or worn floats have been received, see Figure 1. The specified float/bowl clearance **MUST** exist to ensure proper operation.

Floats with Rubbing Wear – FEB 2009
Fig. 1

With the clearance tool M-510 or M-513 (dependent on model) in place, orient the carburetor body with one pontoon uppermost, see Figure 2. Check the clearance between the float pontoon and the bowl wall. A .081 inch gage pin (models MA-2, MA-3 & MA-4), or a .051 gage pin (models MA-4-5, MA-4-5AA, MA-5, MA-5AA, MA-6 and MA-6AA) must pass between the lower surface of the upper pontoon and the throttle bore wall and between the lower surface of the lower pontoon and the lower bowl wall without touching either pontoon. Reorient the carburetor so that the other pontoon is uppermost, see Figure 3. Repeat the clearance check. If, as the gage pin is moved along between the float and the bowl wall the gage pin contacts either pontoon, float clearance is inadequate and the float assembly must be replaced.

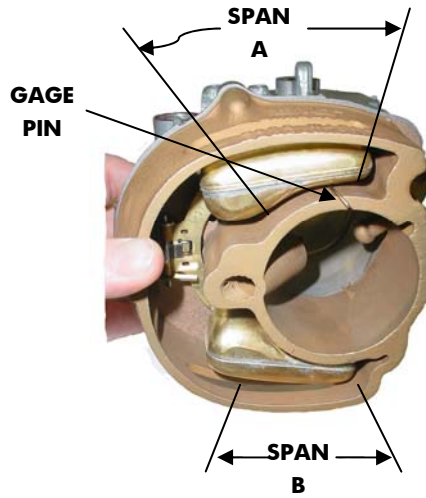
Carb Orientation 1, Check Spans A & B
Fig. 2

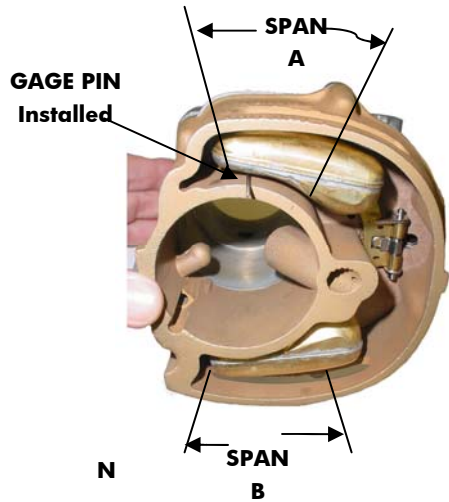
Carb Orientation 2, Check Spans A & B
Fig. 3

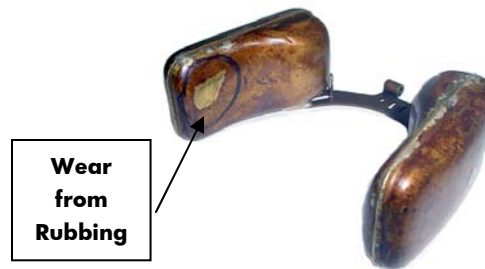
Example: Wear from Rubbing on Large MA Float
Fig. 4

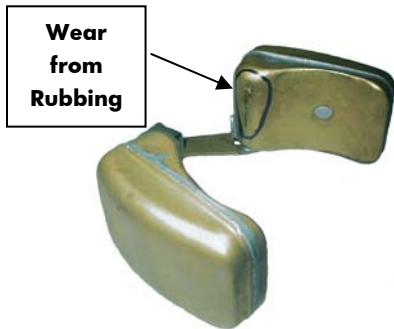
Example: Wear from Rubbing on Small MA Float
Fig. 5

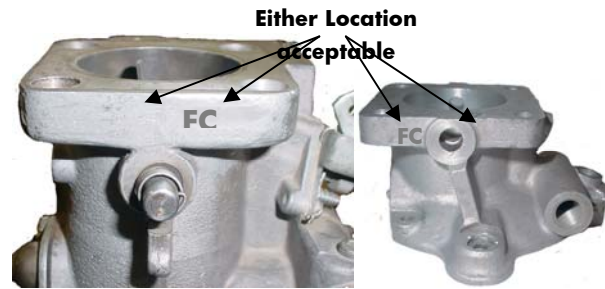
Conformance with this SB-4 'FC' Stamp Locations
Fig. 6

5. **Identification/Marking:** Upon completion of this Flight Safety Service Bulletin, stamp the letters "FC" (1/8 inch tall (nominal) characters) on the flange adjacent to the throttle shaft, see Figure 6.
