**SERVICE BULLETIN**

**SUBJECT:** Recommended Replacement of AEL12892 Thrust Buttons

**PURPOSE:** To notify customers of a potential incorrect material

**AFFECTED:** IO-370-C1F, IO-370-CL, IO-370-CM, IO-370-D3A, IO-370-DA3A type certified engines and spare parts purchased for those engine models.

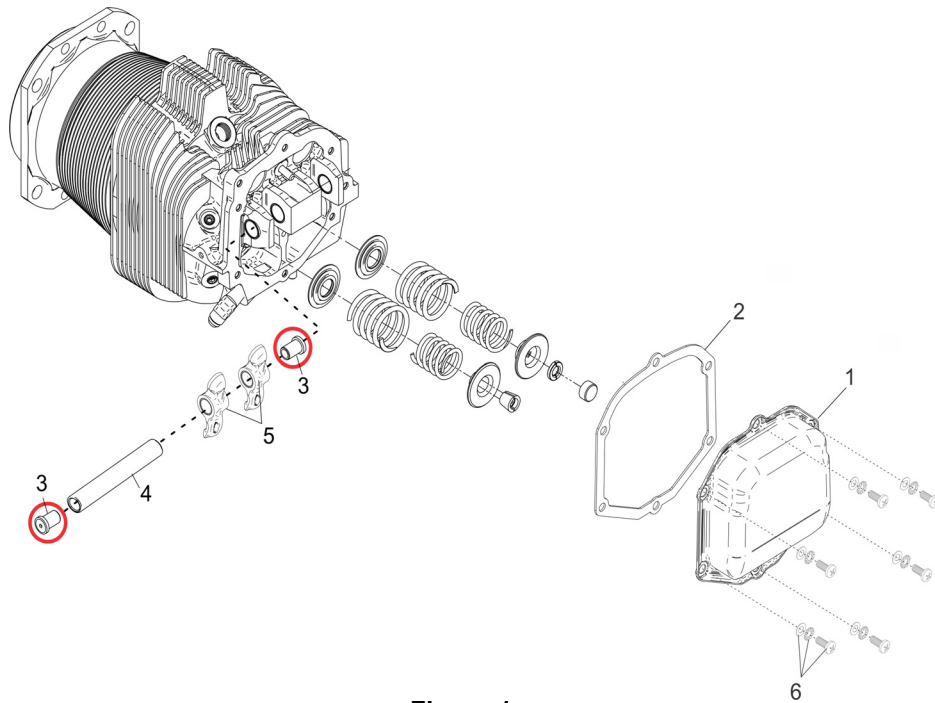
Figure 1.

Continental has been made aware of a potential incorrect material in the AEL12892 thrust button that could accelerate wear. Parts shipped from Continental from 12/25/2023 to 03/11/2026 could be affected. Verify the 8130-3 tag for ship dates.

If signs of overheating or accelerated wear of the thrust button (3) are found, ensure that no debris is present in the cylinder drain back line, oil sump, or in the rocker box area and contact Continental. If none are found, proceed to step 4.

1. Disconnect power to engine.
2. Make sure engine is cool.
3. Remove the rocker cover (Figure 1) (1) and gasket (2) from the cylinder assembly. Discard the gasket (2).

4. Remove the thrust buttons (3). Removal of the shaft (4) and rockers (5) is not required.
5. Replace both thrust buttons (3) regardless of condition.

6. Install the rocker cover (1) with a new gasket (2) on the cylinder assembly.
7. Install and torque hardware (6) to the value specified in the engine's primary Instructions for Continued Airworthiness (ICA).
8. Enable power to the engine.
9. Complete the "Operational Ground Check" per the engine's primary ICA.
10. Make an appropriate engine logbook entry to document compliance with SB26-03.

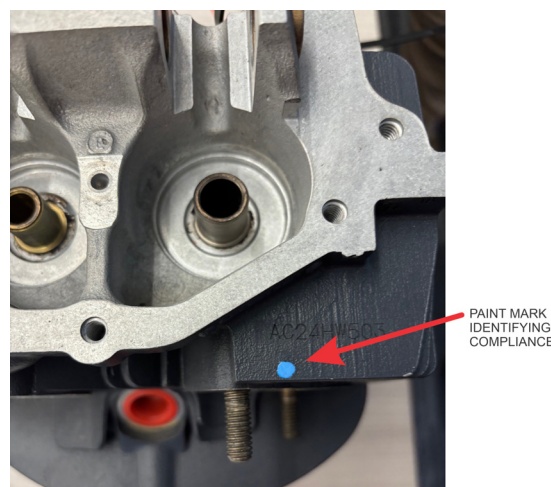
Figure 2.

Continental has verified the material on some cylinders at our distributor's facility. The paint mark shown in Figure 2 identifies compliance. If this mark is on the cylinder, no further action is required.
