CONTINENTAL MOTORS® AIRCRAFT ENGINE
SERVICE INFORMATION LETTER

CATEGORY 5
SIL14-4B

SUBJECT: 24 Volt/70 Amp Belt-Driven Alternator Brace Alignment

PURPOSE: To revise installation and alignment of the 70 Amp Alternator to the bracket and brace.

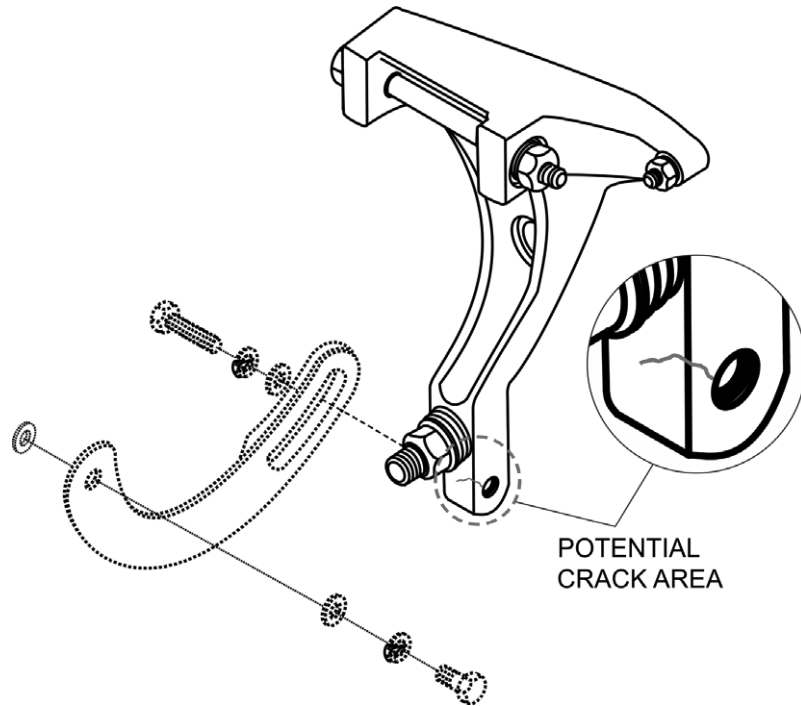
Figure 1. Bracket Assembly Inspection Area

Field reports indicate isolated instances of belt-driven alternator bracket damage caused by improper alignment of the belt-driven alternator to the bracket assembly (Part Number (P/N) 646405), improper alignment of the alternator to the drive sheave, or a combination of both conditions.

Strain gauge testing on the bracket assembly (P/N 646405) indicates negative force applied to the leading edge of the bracket causes excessive strain in the area surrounding the fastener boss and helical coil insert.

3. Perform a visual inspection using a minimum 10x magnifier and bright light source on the cast aluminum bracket to verify the area surrounding the mounting boss and helical coil insert is not cracked (see Figure 1, "Bracket Assembly Inspection Area," on page 2).

- b. If any of the removed components exhibit physical damage or the 10x visual inspection indicates the bracket assembly is cracked, obtain the necessary replacement parts and install according to the instructions in Section IV, "Bracket Assembly Installation," on page 2.

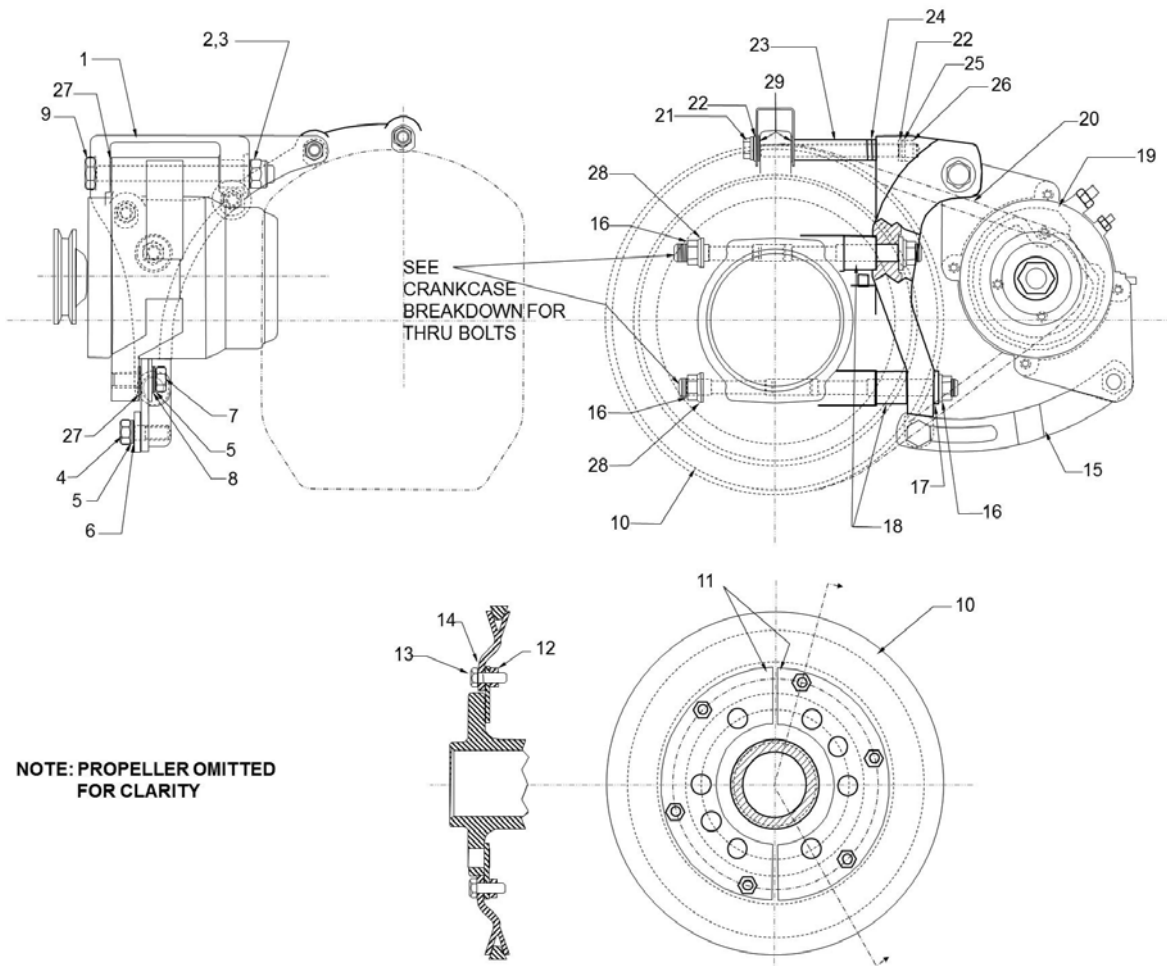
Figure 2. 70 Amp Belt-driven Alternator Assembly

CAUTION: Inserting an incorrect combination of shims (Figure 2, item 24) at the upper mounting location may hinder the proper alignment of the bracket to the engine crankshaft.

1. Install the propeller according to the propeller manufacturer's instructions.
2. Align the holes on the drive sheave (Figure 2, item 10) with the propeller flange holes.
3. Align the split sheave adapters' (11) bolt holes with those in the drive sheave (10).

4. Install six bolts (13) with washers (14) through the front of the drive sheave (10) and split sheave adapter (11) bolt holes. Install a lock nut (12) on each of the six bolts (13); torque the fasteners to 90-100 in. lbs.
5. Install the bracket assembly (1) on the 2-4-6 side of the crankcase with the following hardware:
 - a. Add spacers (18) to the exposed ends of the 2-4-6 crankcase through-bolts at the propeller flange. Secure the bracket to the through-bolts with washers (17) and nuts (16). Do not torque the bracket fasteners at this time.
 - b. If a standard length bolt was installed in crankcase backbone position #3 during crankcase assembly, remove and discard the bolt.

6. Torque the nut (26) to 180-220 in. lbs. Torque the crankcase through-bolt nuts (16) to 490-510 in. lbs. according to the instructions in the applicable Maintenance and Overhaul Manual.
7. Align the alternator assembly (19) upper mounting boss with the mounting bracket assembly (1). Insert a bolt (9) through the bracket assembly (1) and the alternator assembly (19) and securely tighten using washer (2) and new lock nut (3). Do not torque at this time.
8. Check the alignment of the alternator sheave to the drive sheave (10) with a “pulley alignment tool” (P/N 8082IA), or equivalent.
 - a. Place the alignment tool in the center of the alternator drive sheave and lower the opposite end of the alignment tool into the channel of the propeller drive sheave - true alignment must be within 0.016 inch.

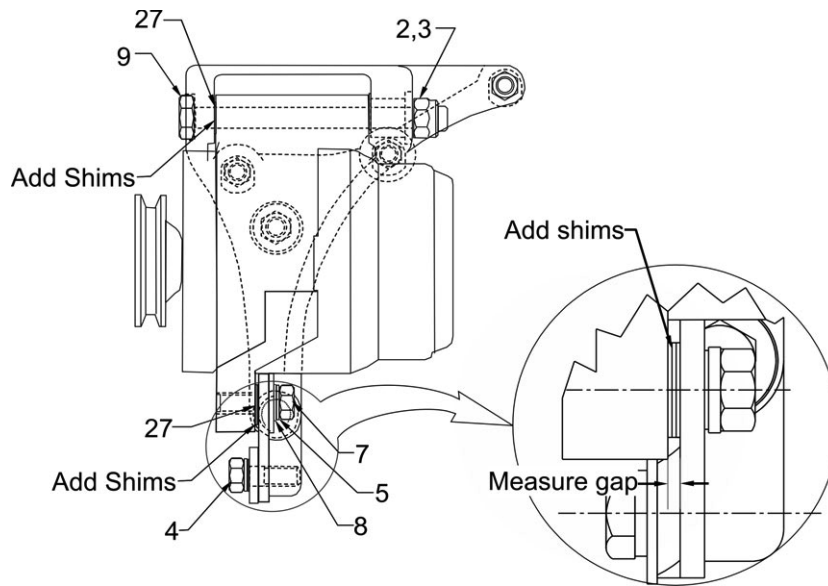
Figure 3. Bracket Shims

CAUTION: No gap is permitted between the alternator brace and the mounting boss. If the gap is between 0.001” and 0.031”, add a shim to fill the void.

- b. If misalignment is greater than 0.016 inch, the alternator is not properly aligned. Align the two sheaves by first removing the lock nut (3) and washer (2) from the bolt (9) and insert shims (27) between the forward boss of the mounting bracket (1) and the upper alternator assembly (19) mounting (see Figure 3, “Bracket Shims,” on page 5). Secure the bolt (9) and torque the nut (3) to 250 in. lbs. to seat the alternator bracket bushing then back-off the nut (3) one full-turn counter-clockwise.

11. Measure the gap between the outboard alternator mounting boss and the lower brace with a caliper to determine the number of shims (Figure 2, item 27) to completely fill the gap between the adjustable brace (15) and the alternator mounting boss (19). No gap is permitted between the two surfaces; the thickness of the shims to fill the gap may exceed the distance between the brace and alternator by up to 0.031”.

12. Loosen the pivot bolt (Figure 3, item 4) and insert shims (27) to completely fill the gap between the brace and the outboard alternator mounting boss. Install adjustment bolt (7), new lock washer (5), and washer (8) through the shims (27) and adjustable brace (15) and into the threaded outboard alternator mounting boss.
