CONTINENTAL MOTORS® AIRCRAFT ENGINE
CRITICAL SERVICE BULLETIN
COMPLIANCE NECESSARY TO MAINTAIN SAFETY

Category 2
CSB07-2A

SUBJECT: Turbocharger Wastegate Oil Inlet Fitting Inspection and Replacement

PURPOSE: To provide instructions for the inspection of the turbocharger wastegate oil inlet fitting for possible chafing on the adjacent structure and to provide instructions for fitting replacement.

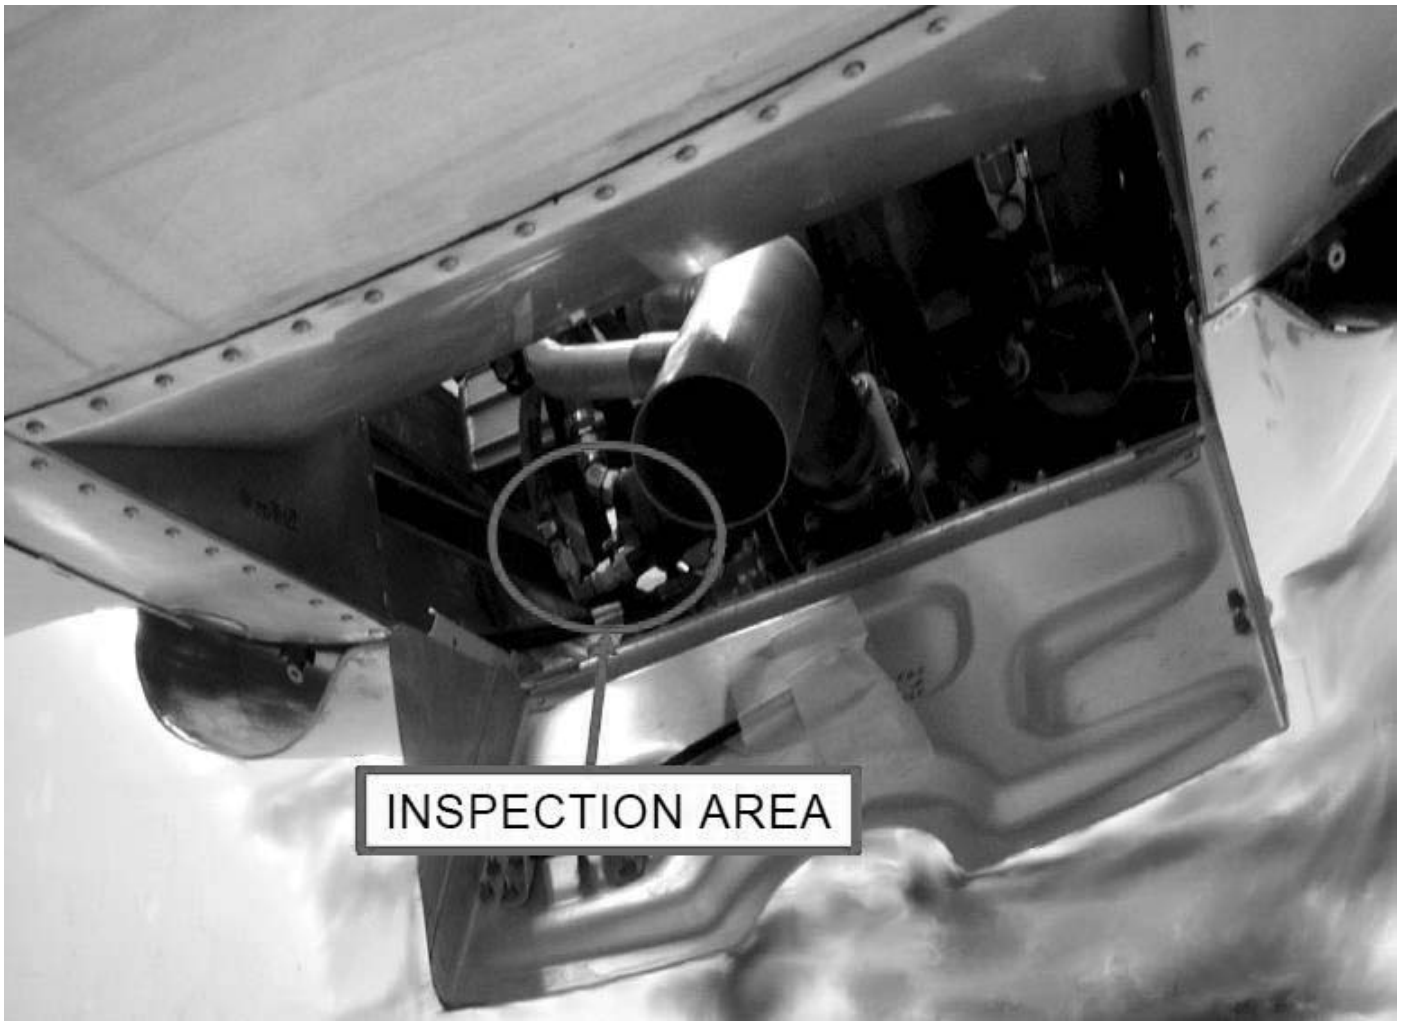
**FIGURE 1
INSPECTION AREA**

1. Using the airframe manufacturer's maintenance instructions, open or disconnect each engine cowl flap to allow access to the wastegate actuator. (Reference Figure 1)
2. Inspect the oil inlet fitting of the wastegate actuator.
3. If the fitting is a one-piece 90° fitting as shown in Figure 2A, no further action is required. Reassemble the previously removed airframe components using the applicable airframe manufacturer's maintenance instructions. Make engine log book entries for each engine inspected certifying compliance with this Critical Service Bulletin.
4. If the fitting is a two-piece assembly (straight fitting and 90-degree fitting) as shown in Figure 2B, proceed to the fitting replacement instructions contained in this Critical Service Bulletin.

1. Using the airframe manufacturer's maintenance instructions, open or disconnect the engine cowl flaps and remove the engine cowling as necessary to allow access to the wastegate actuator. (Reference Figure 1)

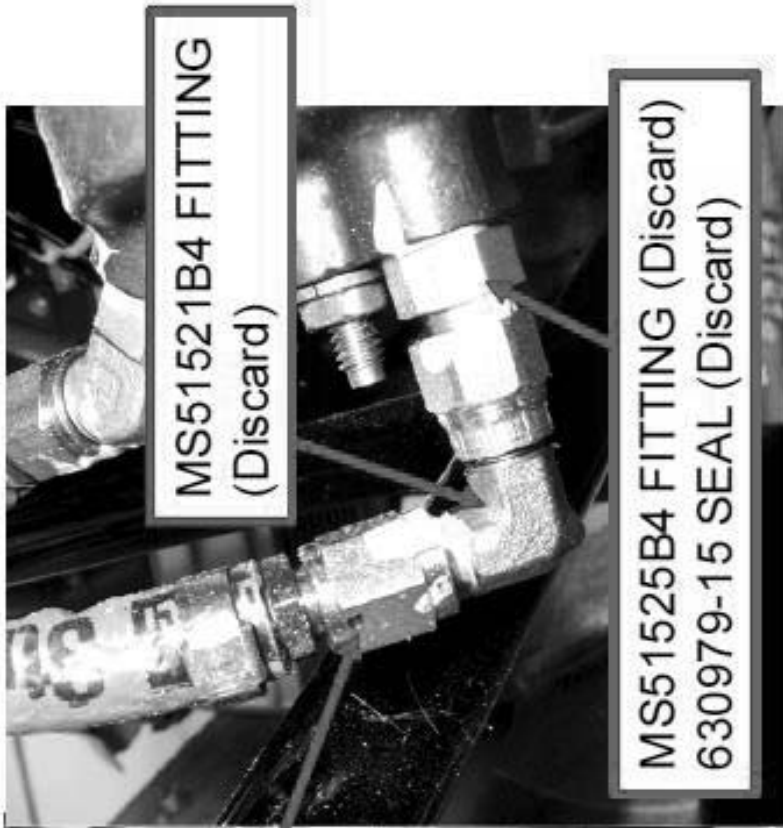
**FIGURE 2B
OLD INSTALLATION**

MS51521B4 FITTING
(Discard)

MS51525B4 FITTING (Discard)
630979-15 SEAL (Discard)

3. Remove the 90-degree fitting P/N MS51521B4, straight fitting MS51525B4, and O-ring seal P/N 630979-15 from the oil inlet on the wastegate and discard. (Reference Figure 3)

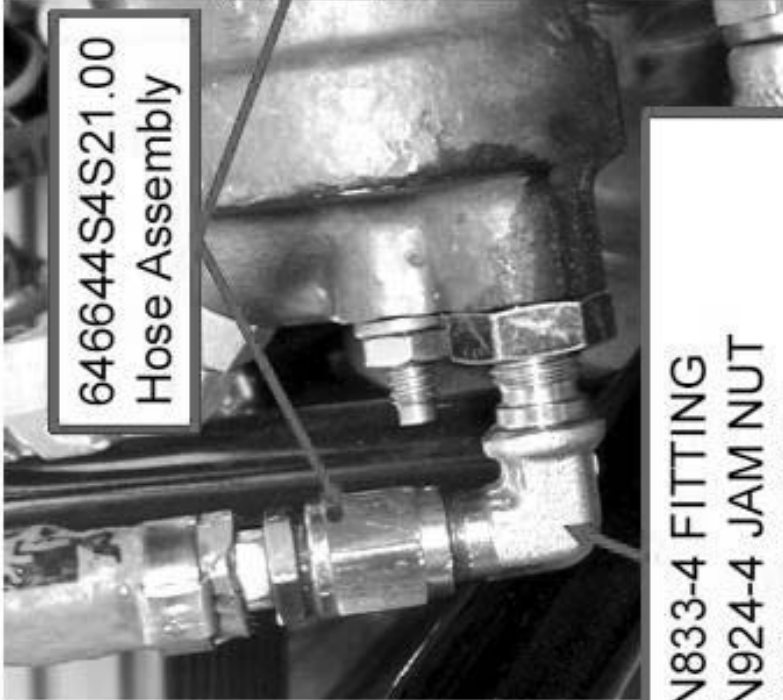
**FIGURE 2A
NEW INSTALLATION**

646644S4S21.00
Hose Assembly

AN833-4 FITTING
AN924-4 JAM NUT
630979-15 SEAL
(Alternate Seal MS28778-4)

6. Install replacement 90-degree fitting P/N AN833-4 with new O-ring P/N 630979-15 (O-Ring P/N MS28778-4 is an approved alternate) and jam nut P/N AN924-4. Lightly lubricate the O-ring with clean 50W engine oil before installation.

7. Clock the P/N AN833-4 fitting to allow connection of wastegate oil pressure hose while maintaining sufficient clearance between the fitting and the airframe engine mount structure. While holding the fitting in position to ensure clearance between the fitting and the airframe engine mount structure, ensure that the O-ring is seated in the relief boss on the fitting. Screw
